# Koolan Iron Ore Mine and Port Facility Mine Closure Plan

Revision 7 Version 0

31 January 2025

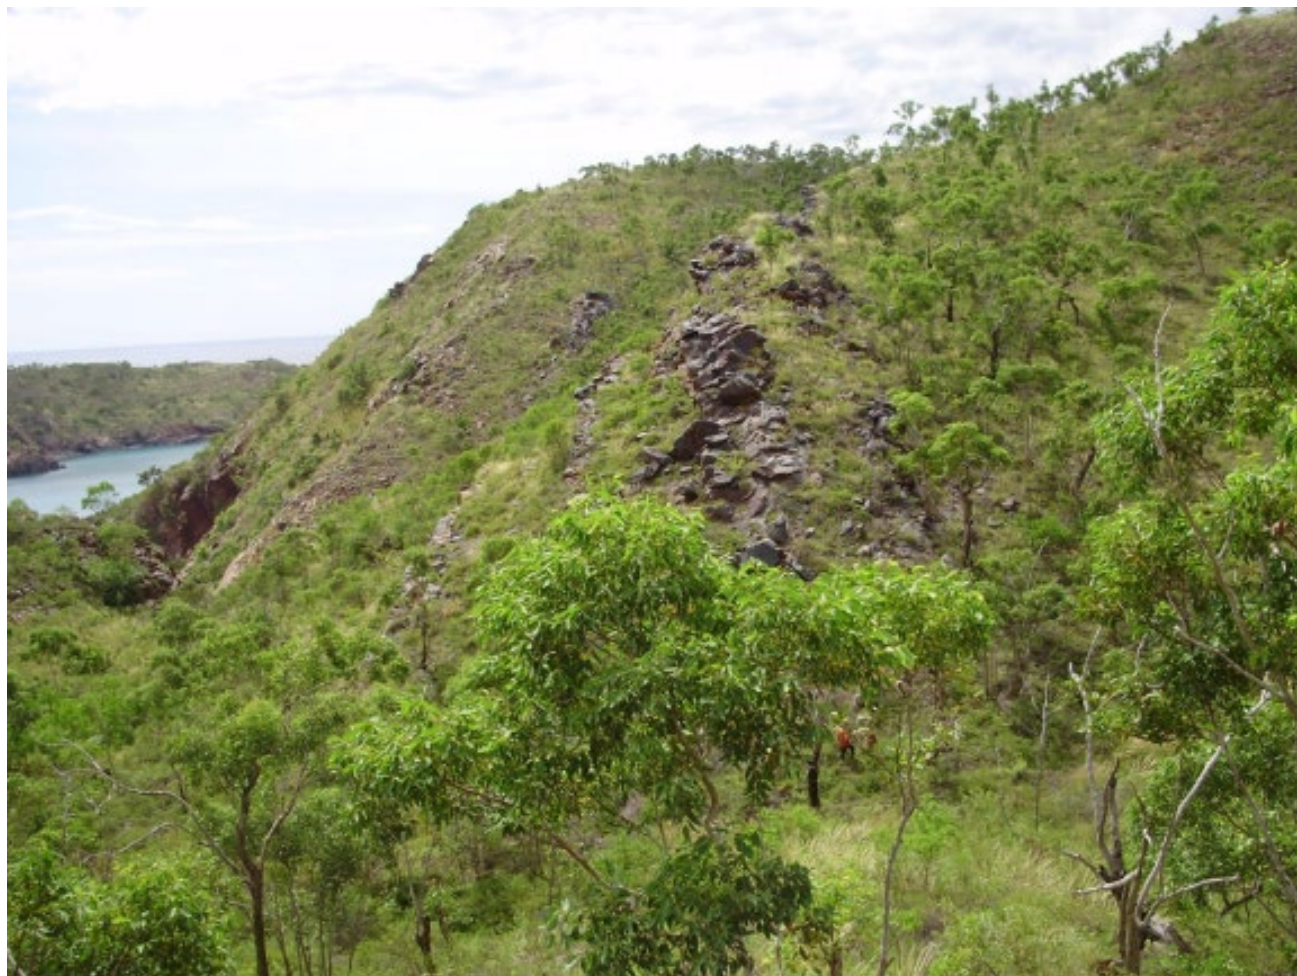
**Figure 12: Steep gully feature typical of Koolan Island topography, natural terrain by durable native rock.**

Koolan Island's Proterozoic sandstone lithology is expressed as rugged slopes, ridges and uplands mantled with rock scree and shallow skeletal soils (**Figure 12**). The coast is steep with narrow gullies and frequent embayments, but few beaches. There are no known permanent creeks or pools (GHD, 2010). Natural slope angles can be in excess of 40° with frequent outcropping of the bedrock geological units occurring over the entire Island.

The rugged topography of the Island coupled with tropical rainfall events naturally limits the formation of deep soil profiles. The prevalence of steep slopes (**Figure 12**) over much of the Island and the extensive rock outcrop makes stripping of the fine skeletal topsoil challenging from an operational and safety viewpoint.

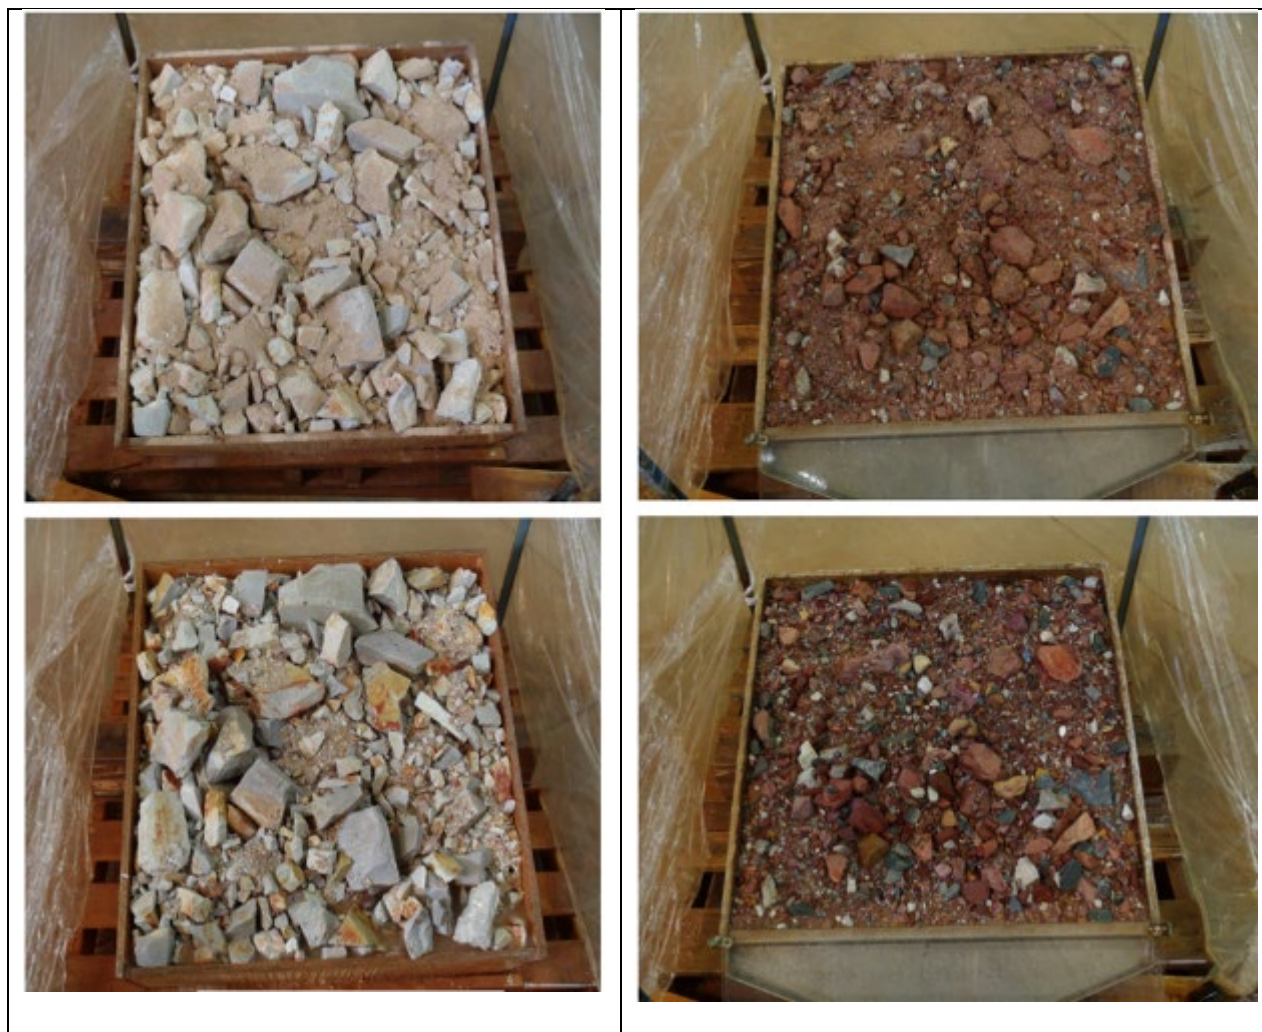
**Figure 14 Quartzite (LHS) and WD1 Siltstone (RHS) before and after rainfall simulation**

The increase in silt content and slightly higher clay contents (as compared to quartzite) result in Plant Available Water (PAW) being slightly higher within the waste rock siltstone. As was the case with quartzite, rehabilitated and undisturbed profiles contain higher PAW contents. In contrast to the quartzite and sandstone profiles, siltstone rehabilitated and undisturbed profiles contained significantly increased PAW (up to 4 times) content, suggesting that the on-going physical and chemical weathering of this material will provide larger increases in fine materials (and therefore PAW) than other materials tested. The siltstone material with higher PAW confirms this waste rock type as a suitable rehabilitation cover system. SoilWater Consultants (Soilwater Consultants, 2014c) did note that different blends of siltstone waste rock have different erodibility ranging from low (Main Pit Schist), moderate (1170) to high (WD1) (**Figure 14**).

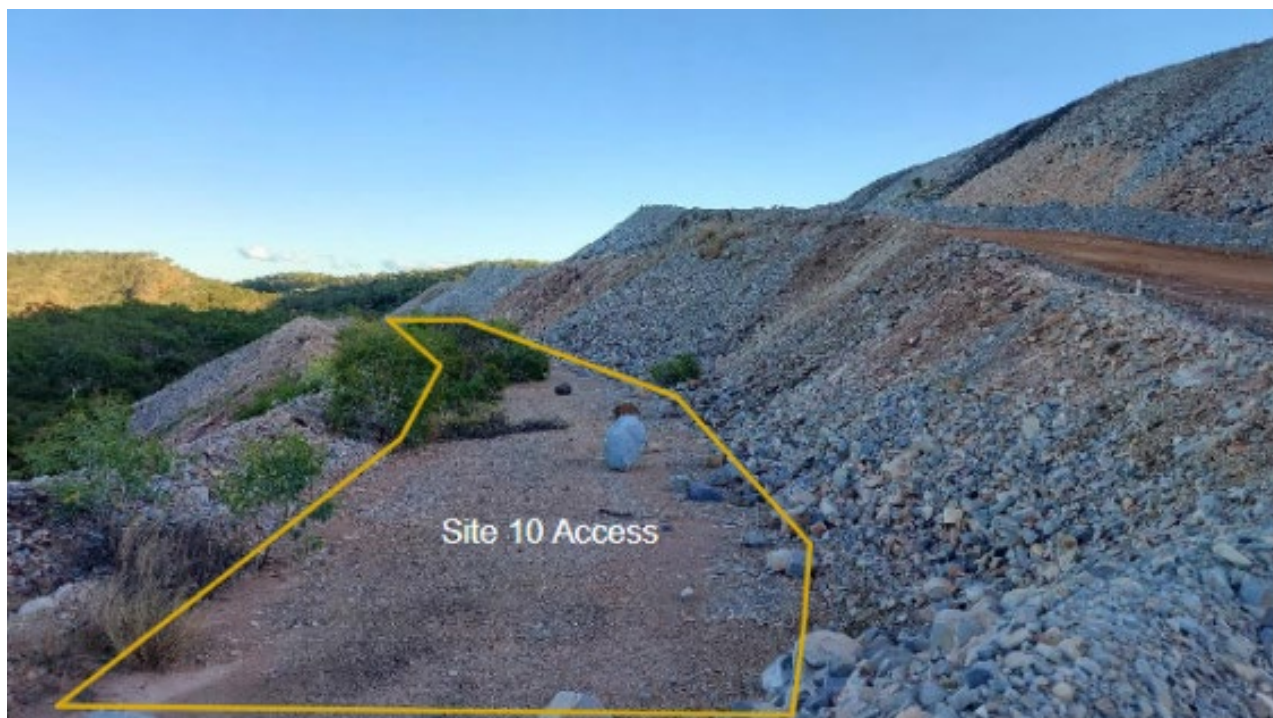
Figure 19: Test site on a berm below a lift on north side WD1.

Multiple test locations (27 pits) are identified based on the surface topography and slope gradients, and to be representative of the wider rockfill mass including their dominant lithographies. Indicative locations are marked in **Figure 18**. Excavations would be made to the *order of a cubic metre* to make available representative near-surface rock in a near crest situation potentially prone to future erosion, weathering, and failure. Points of test pitting by backhoe excavation situated on berms and/or beneath outer slopes of lifts, example of which can be seen in **Figure 19**.

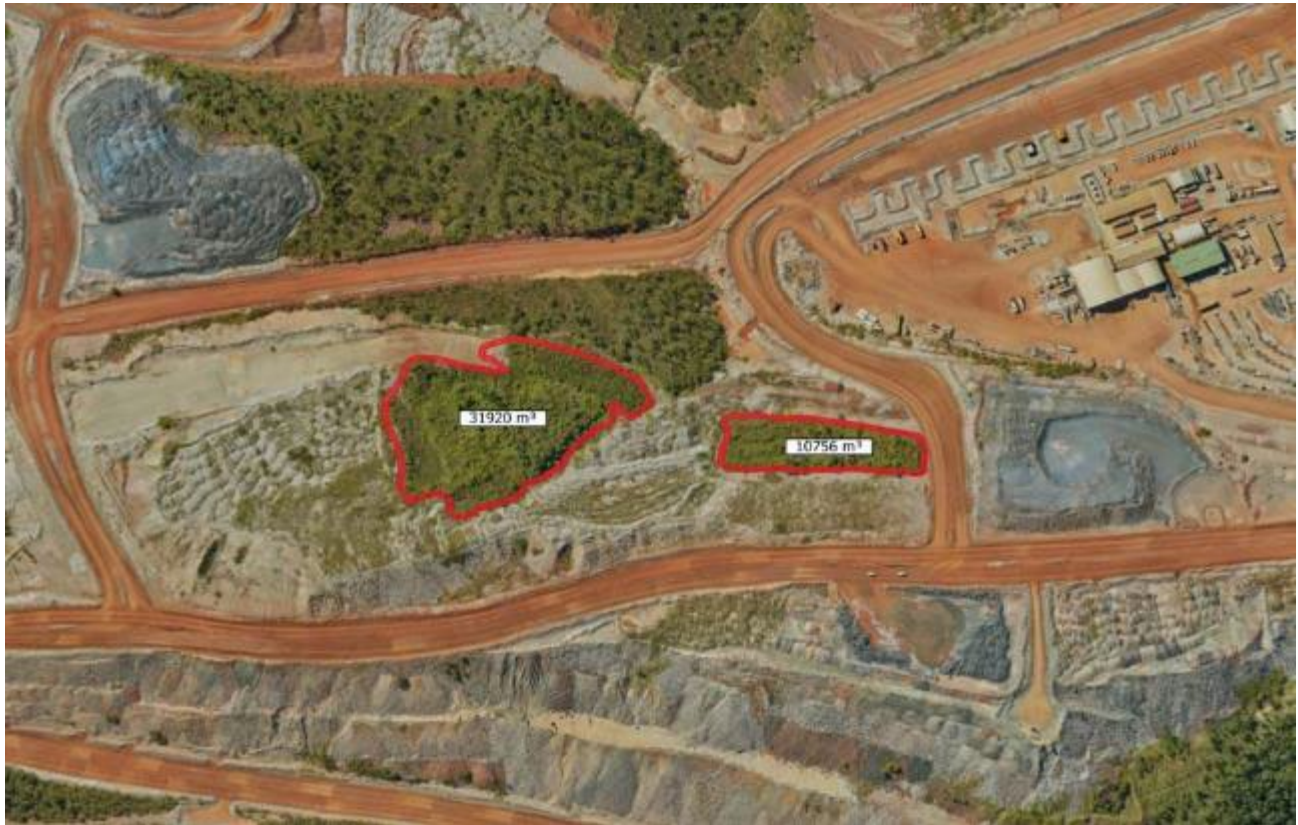
**Figure 21: Location and Volumes of Topsoil Stockpiles on WD2**

Most recent survey results, undertaken in 2024, have indicated that there is currently approximately 129,000m<sup>3</sup> of topsoil stockpiled across site (**Figure 21** and **Figure 22**). There is an ongoing scope of work to understand the availability of siltstone and quartzite. While there is an overarching surplus of siltstone that has been mined from Koolan Island there is an outstanding knowledge gap to understand the availability and quality of growth medium and the final closure geometry to understand the final balance.

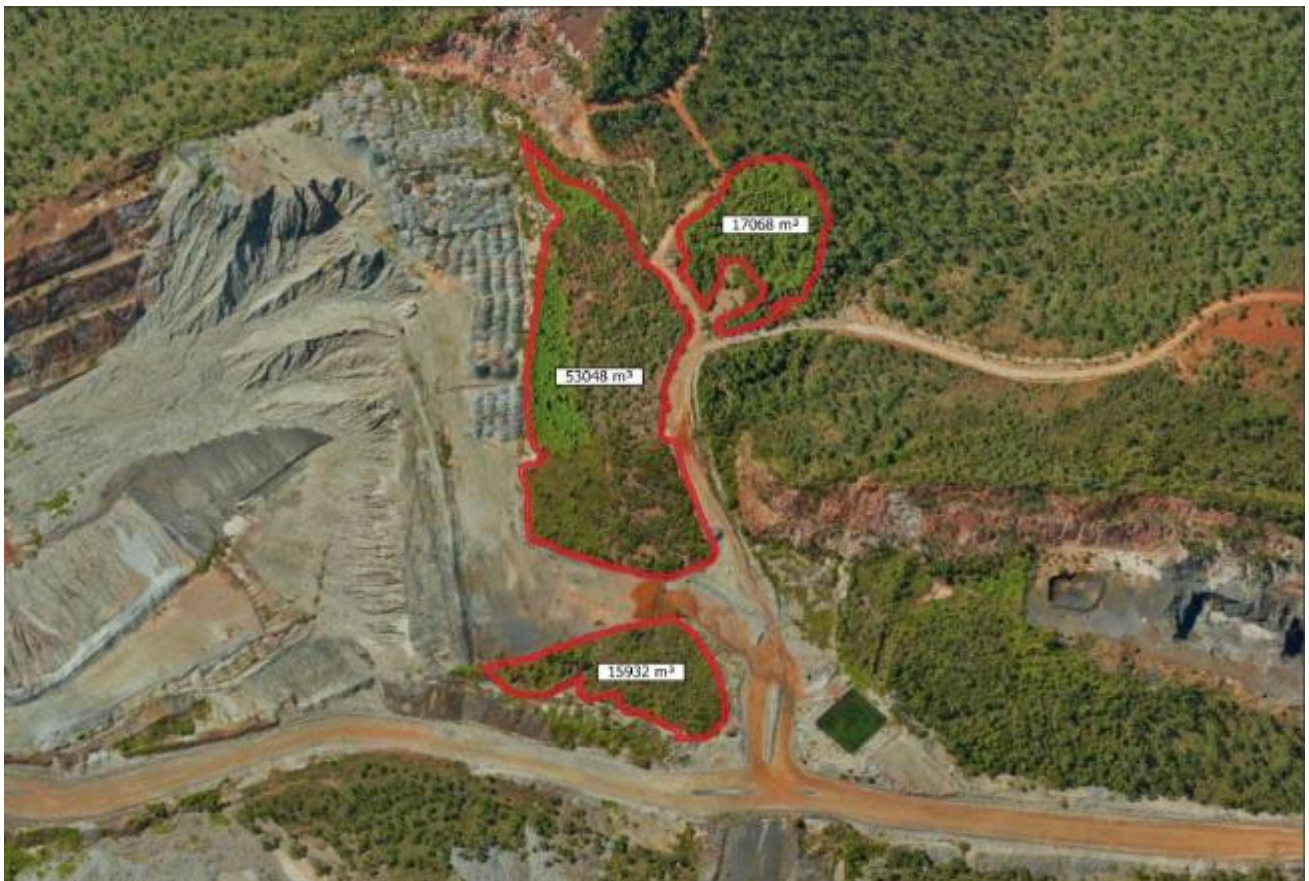
**Figure 22: Location and Volumes of Topsoil Stockpiles at Mullet / Acacia Pit**

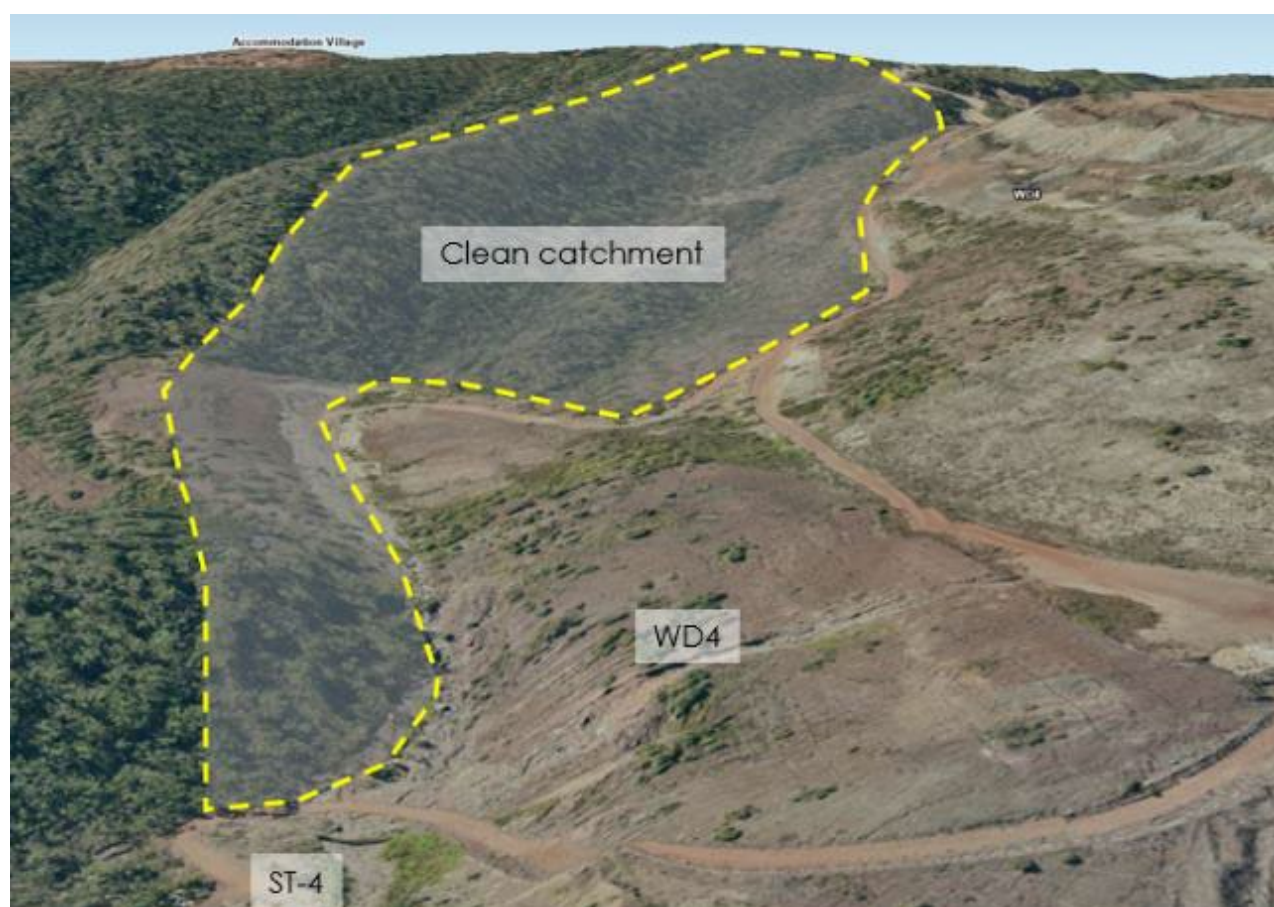
**Figure 28: Clean sub-catchment on north side of Pindan Creek reporting to Sediment Trap 4**

hectares of relatively undisturbed land that flows through to a renovated Sediment Trap (ST-4) as illustrated in **Figure 28**.

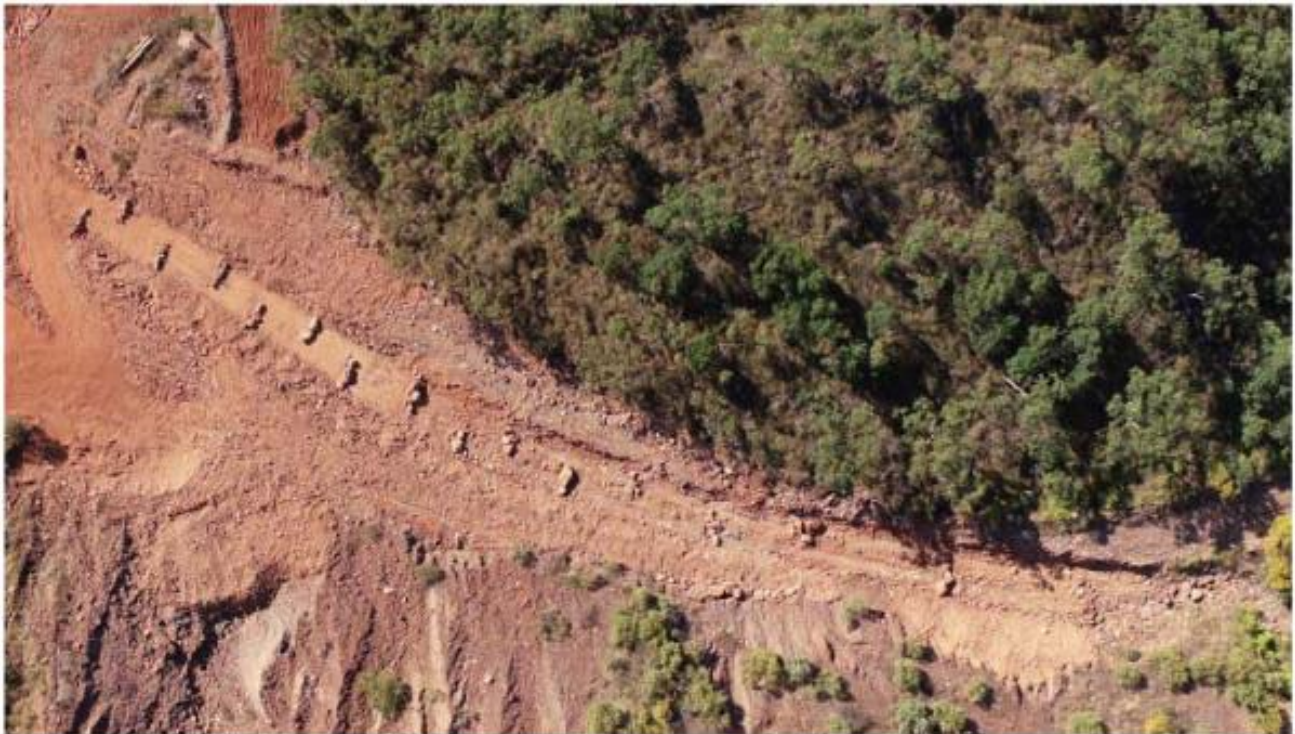
**Figure 30: Sediment Trap (ST-4) after excavation of entrained sediments during 2022 dry season.**

Sediment Trap 4 (ST-4) constructed and operated by approved stormwater management plan for control of drainage water reporting to Pindan Bay. This has been used to date as the principal form of sediment control (**Figure 30**).

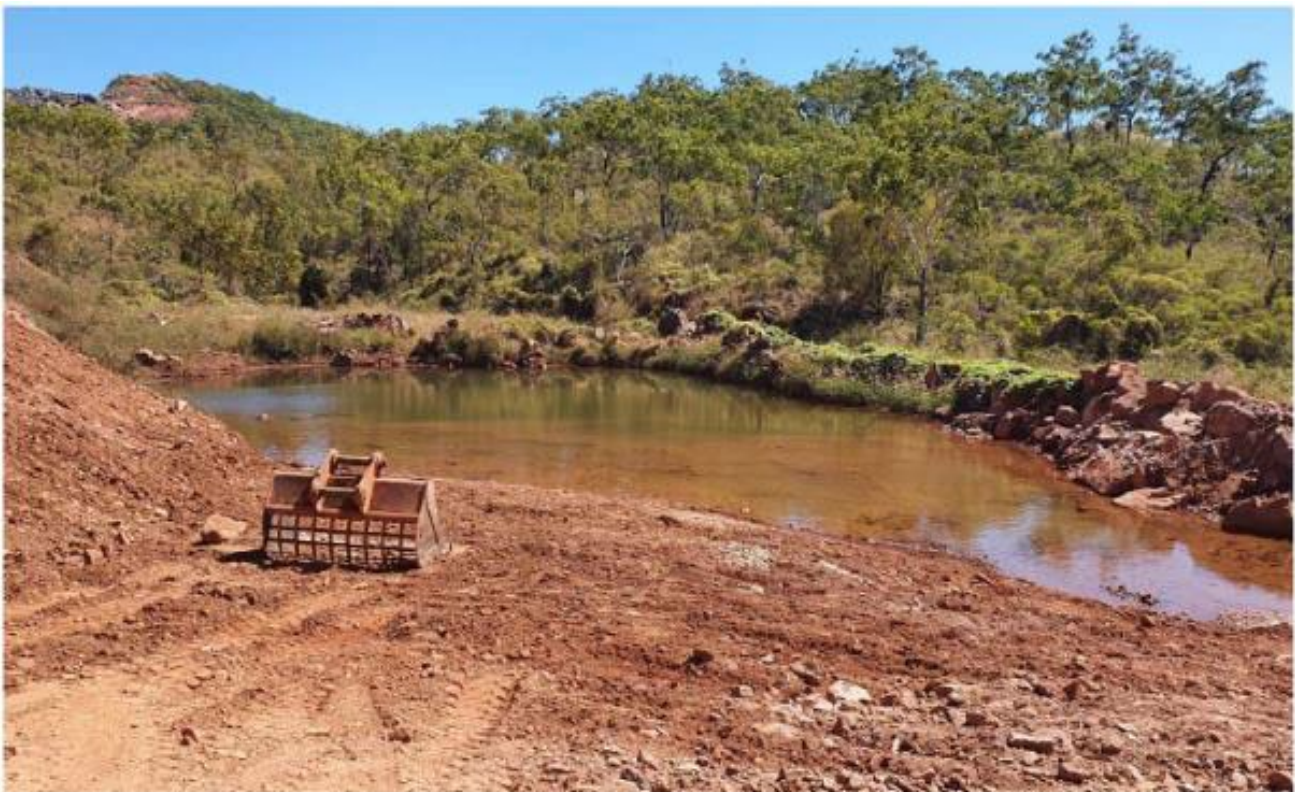
**Figure 31: Drainage improvement on the bed of Pindan Creek below WD4. Earthworks to stabilise the bed and installation of rock baffles**

Specific local area drainage improvements substantially reduce sediment loads generated from more erodible cells of landforms, including WD4 (**Figure 31**). There had been erosion down the centre of the upper lift of WD4 slope (**Figure 32**), which is exacerbated by surface water down the slope's face. Re-grading the upper surface to minimise the surface water flowing downslope will reduce sediment load substantially. A drainage improvement has already been implemented to improve outcomes on reshaped slopes and covers (**Figure 33**).

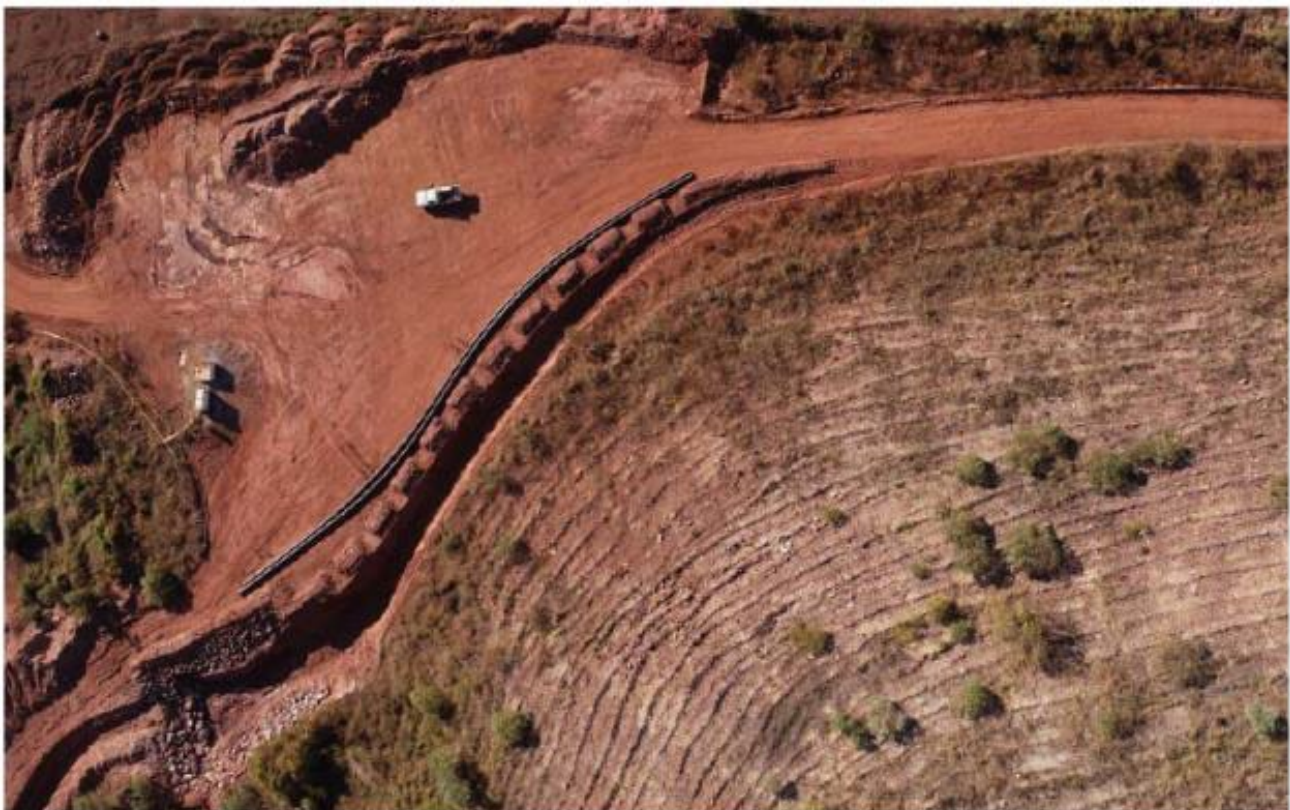
**Figure 33: Drainage improvement at the crest of WD4 between waste dump lifts (July 2022). Water from runoff on upper lift is intercepted and directed away from erosive face of a lower lift.**

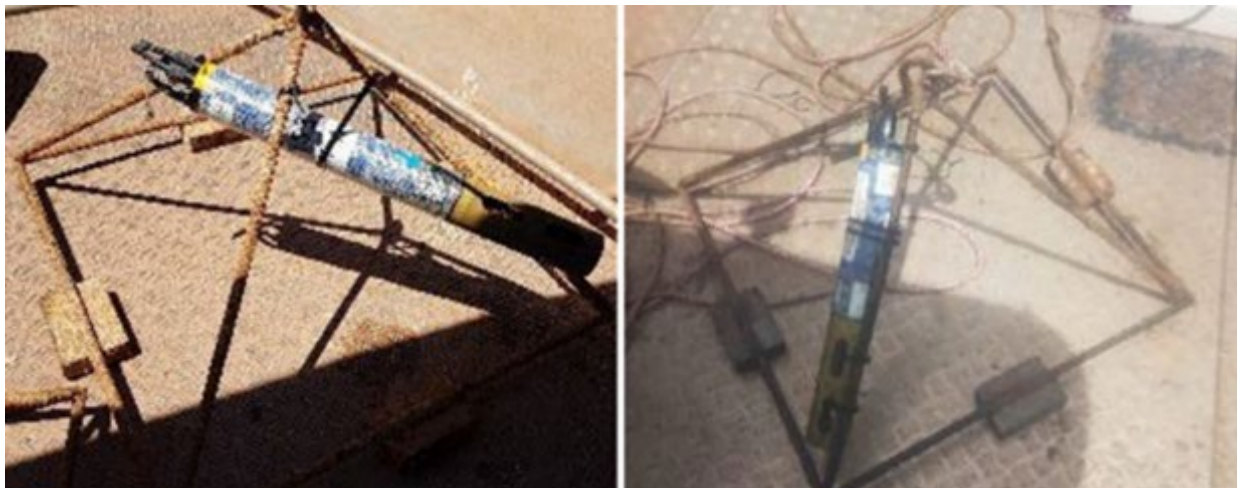
**Figure 43: Remote submerged data logger (SDL) EX02 (left) and EX03 (right) water quality sondes, attached to custom weighted frames prior to deployment**

The program used three EXO submersible data loggers (nephelometers) measuring turbidity, temperature, salinity and oxygen, with the emphasis on turbidity (**Figure 43**). Two SDLs were placed at the east and western boundaries of the diffuser mixing zone and the third at a reference site at the western end of the Canal.

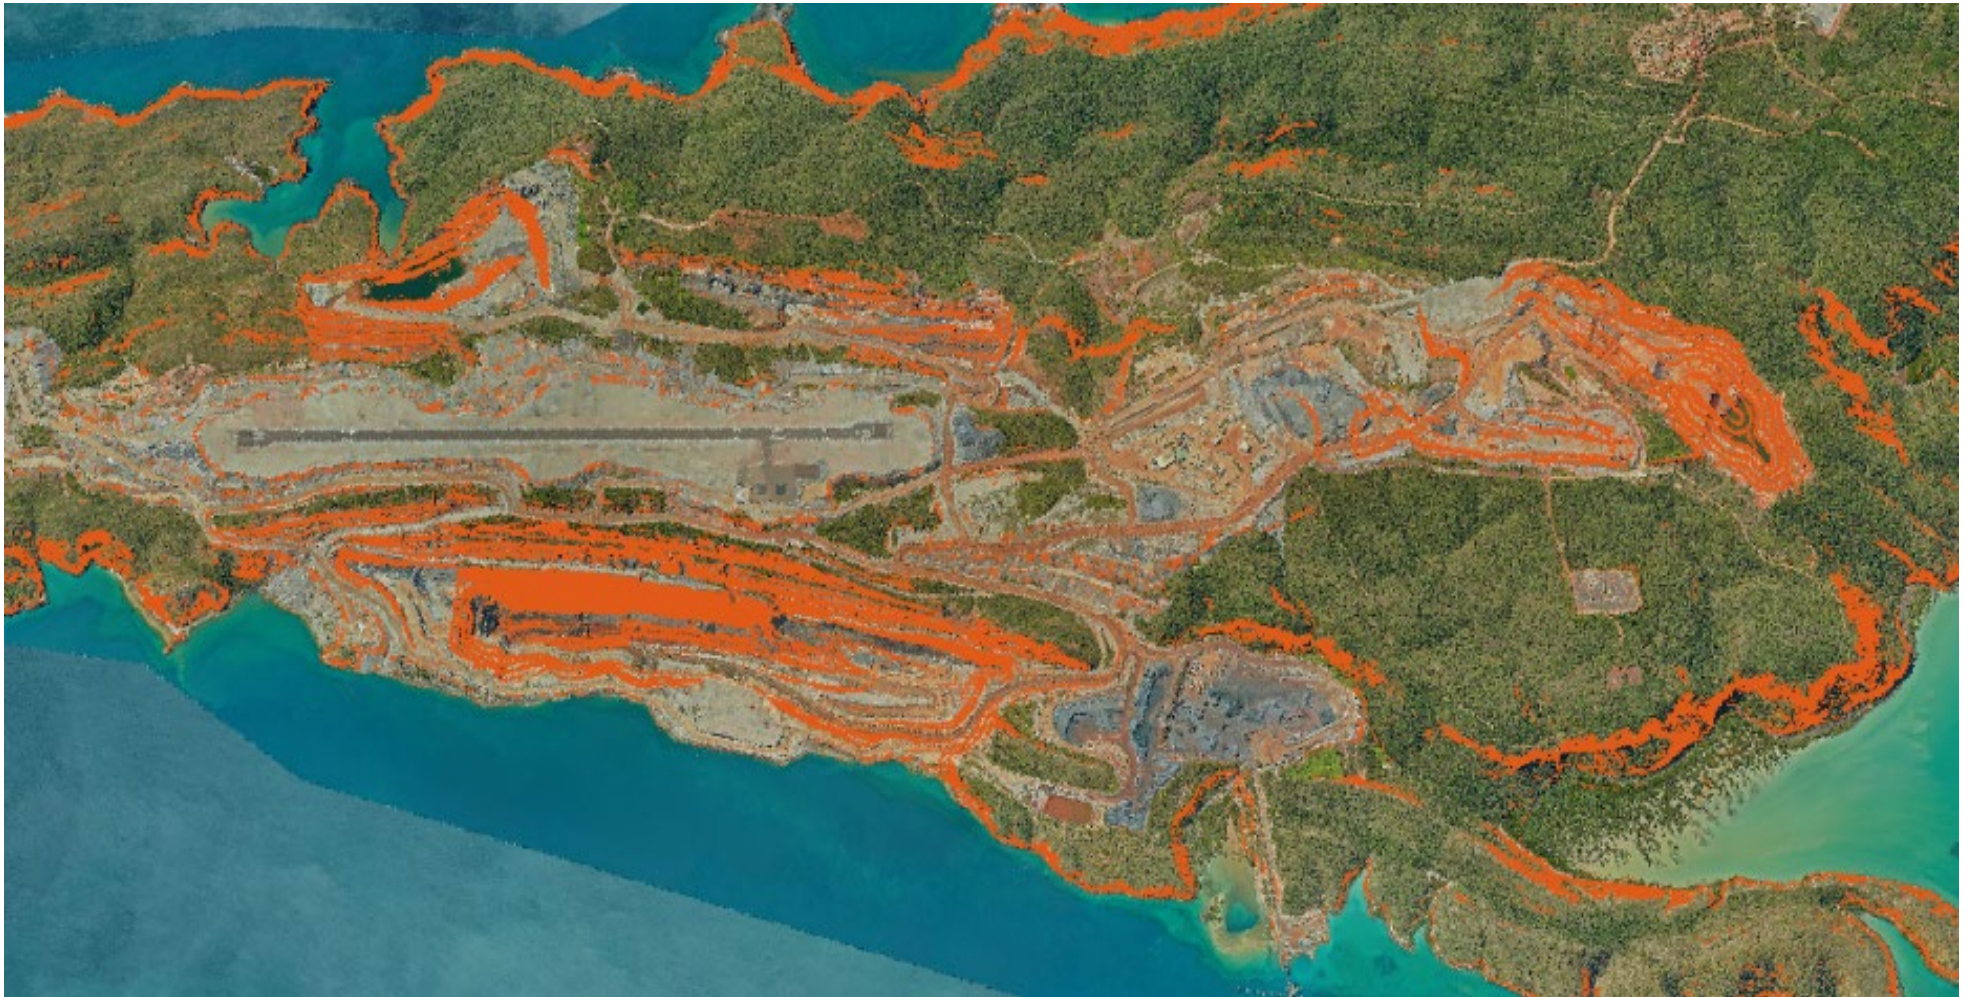
**Figure 60: Slope assessment. Red highlighting indicates a slope of 37° or greater.**

An overview of the placement of Abandonment bunds is shown in **Figure 59** and a site wide slope assessment is **Figure 60**, specific closure bund designs and placement for each pit is outlined in section 21.

The northern shoreline of Koolan Island is highly rugged with very steep slopes or cliffs protecting mining areas being accessed from the sea. The slope angle analysis in **Figure 60** highlights the steep topography. There are no safe landings for vessels on the northern shoreline and the small beaches are flanked by cliffs which make traversing them extremely difficult. It is considered that the likelihood of inadvertent access to any mining areas from the Northern shore is very unlikely. Therefore, it is considered that this natural topography meets the intent of the Safety Bund Walls around Abandoned Open Pit Mines Guidelines (Department of Industry and Resources, 1997).

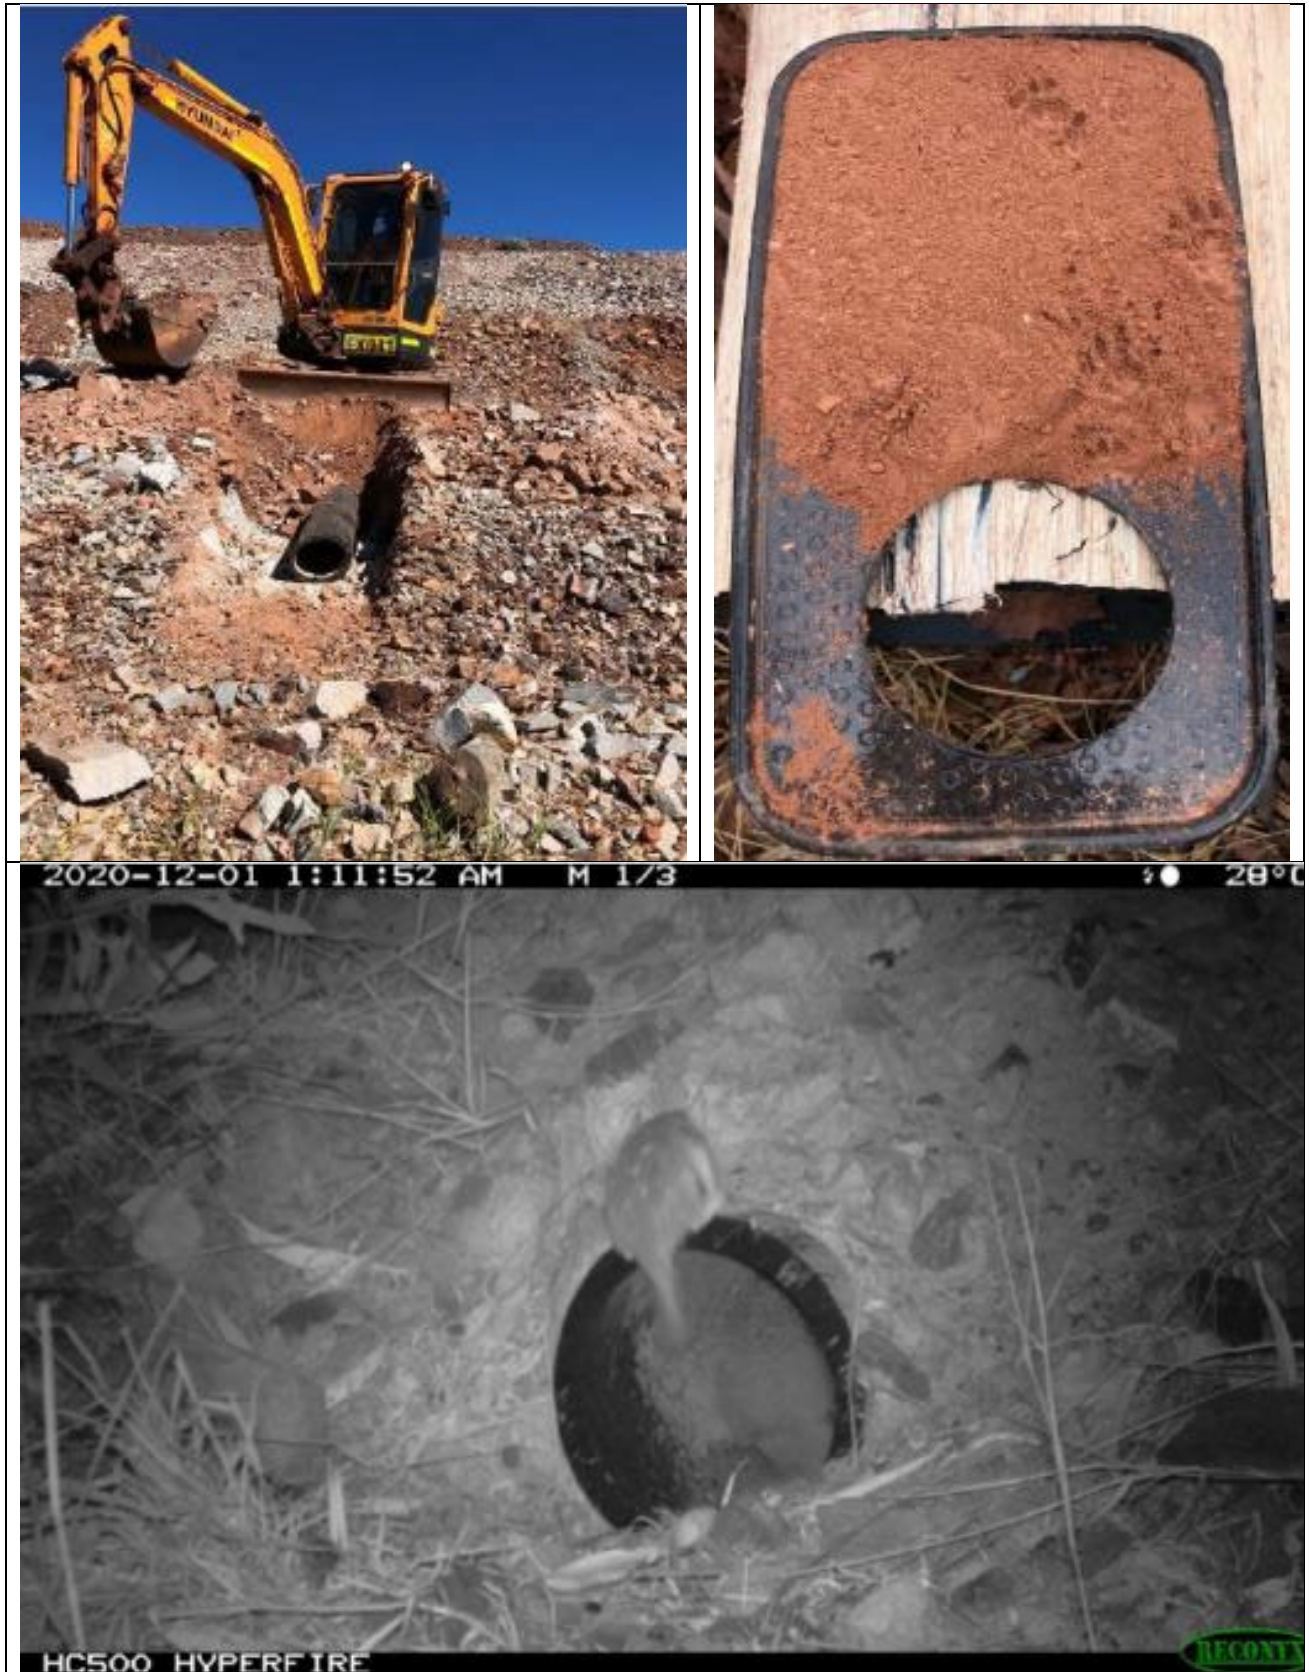
**Figure 68** Installing 2m lengths of PN14 pipe (LHS); Quoll footprints at 'den' entrance (RHS). Quoll inspecting (below).

To understand how to ensure Northern Quolls will reinhabit rehabilitated landforms KIO trialled the installation of artificial dens into a trial rehabilitation slope on WD4. The project area encompassed habitats and vegetation associations which are widespread throughout the region. Some of the species listed in the CALM Priority are considered regionally significant because of limited knowledge about their distribution and / or poor representation within existing conservation reserves.

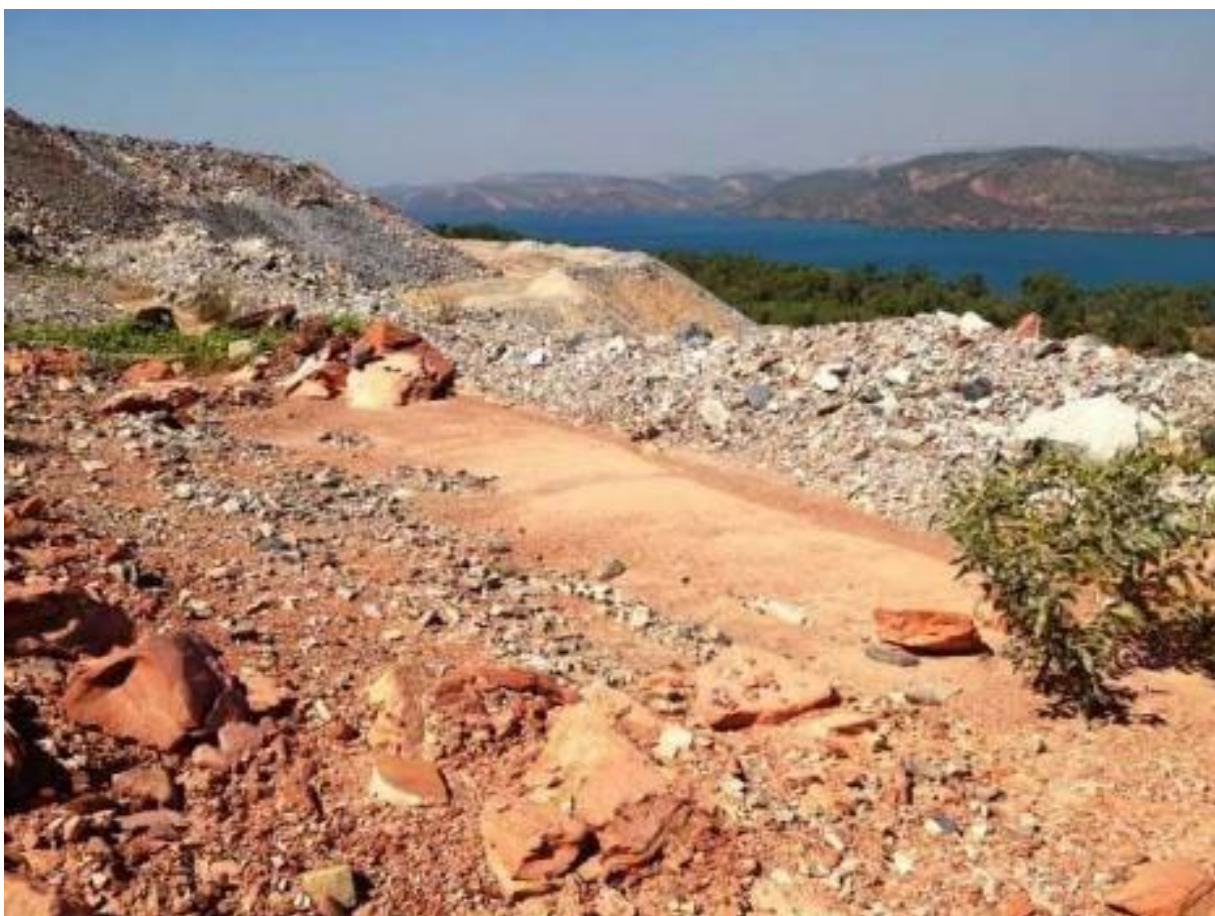
**Figure 72 Accumulation of sediment on catch berm in 2015**

The earlier work of APM (Animal Plant Mineral, 2019) and eMapper (eMapper, 2019) considered the effectiveness of the trials in relation to FA and photogram metric analyses. Some erosion at the trials was visually evident initially in 2015. A catchment berm proved effective retention of sediment eroded from the trial plots (**Figure 72**). Encouragingly, the erosion did not significantly advance by 2019, indicating that the rate of erosion reduced over time after surface cover was laid.

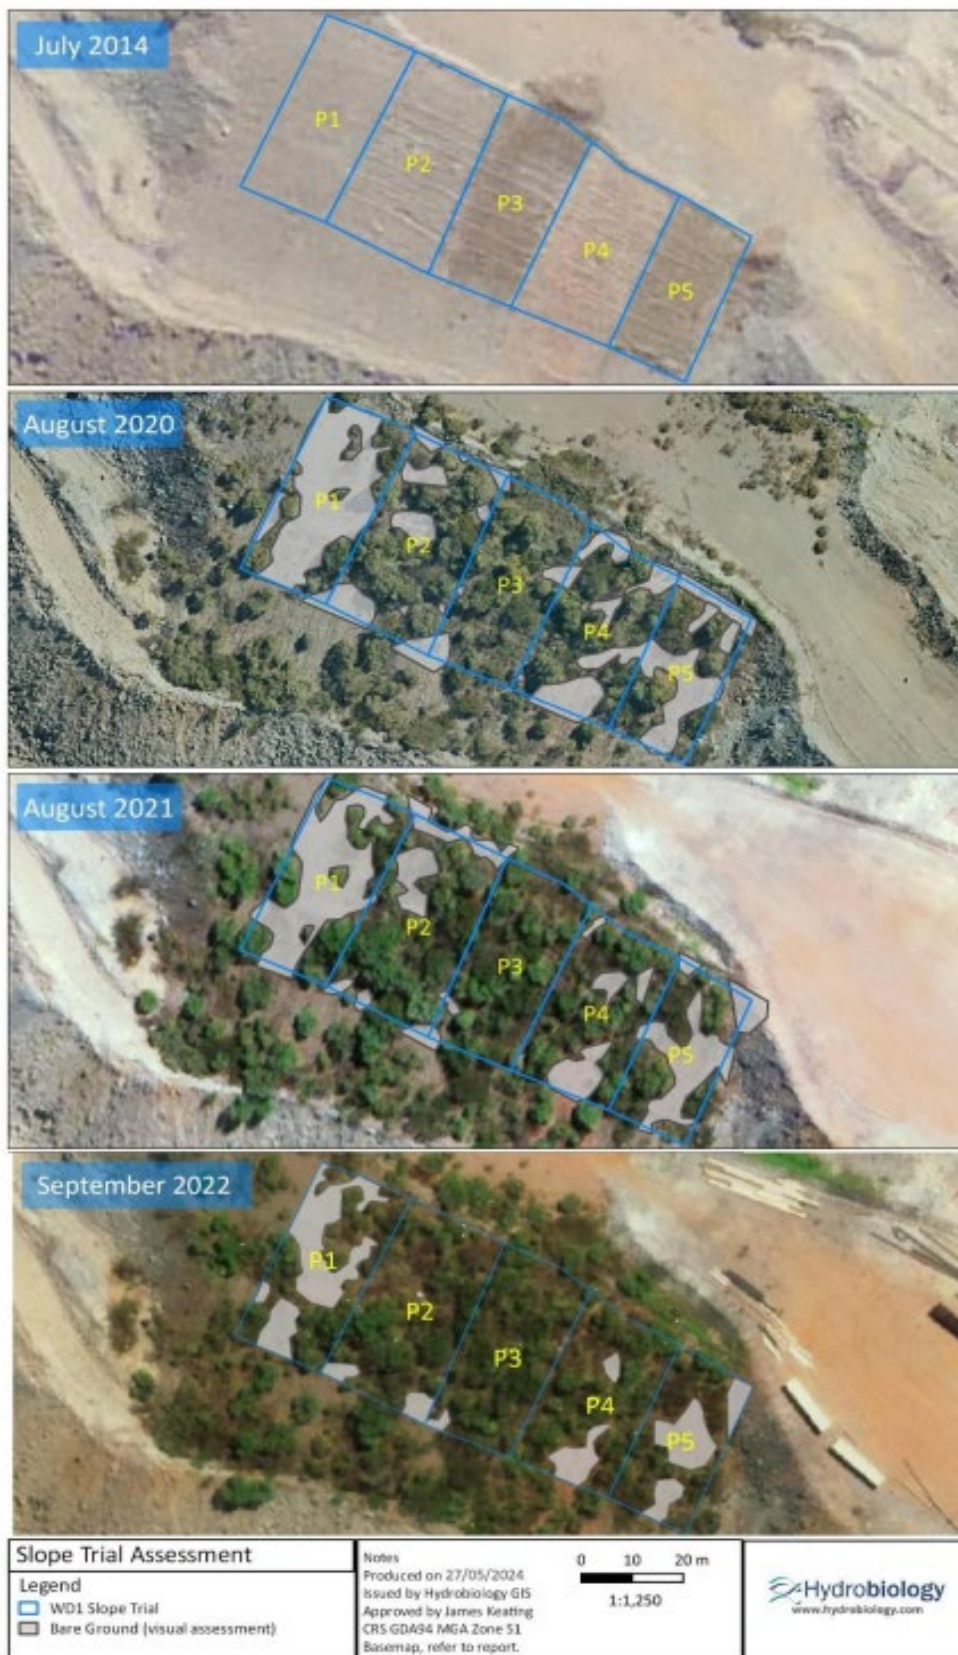
**Figure 73 WD1 slope trial, with bare earth differentiated from vegetation cover by visual assessment.**

The results of the assessment for each slope trial treatment are shown in **Figure 73** and described in (**Table 29**). The most effective treatment based on vegetative growth was trial plot T-3, with 0.1 m layer of topsoil, ripped on contour to approximately 0.5m. The next most effective treatment was T-2, which had no additional substrate added, only mechanical modification of ripped on contour to approximately 0.5m.

Siltstone (T-4) was found to be a more effective substrate for vegetation growth when compared with the weathered sandstone sourced from Acacia East (T-5). However, the proximity of T-5 to the sloped access road may have affected independence of this trial plot through excess dusting or erosion.

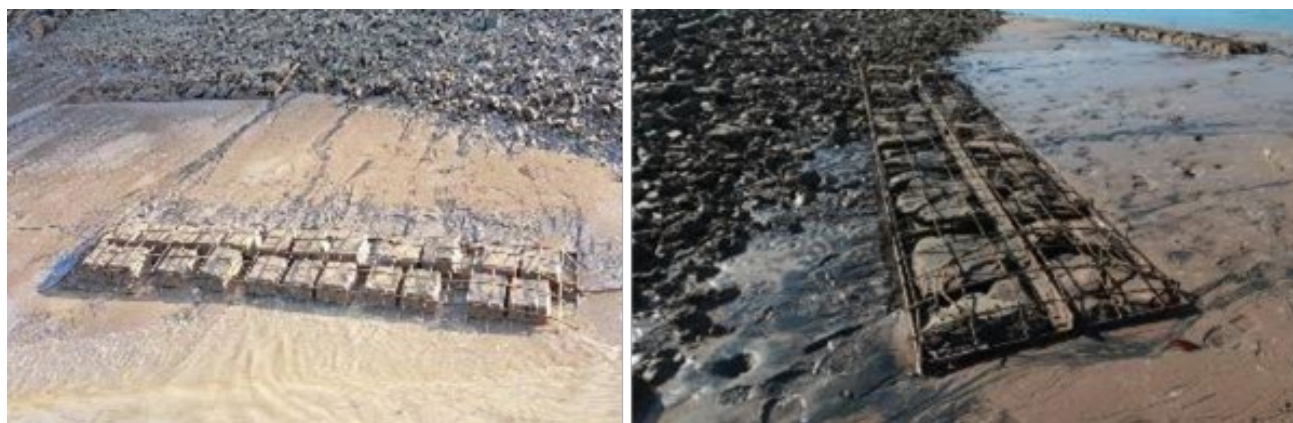
**Figure 77 Exposed concrete (left) and siltstone (right) frames**

Substrates were deployed (**Figure 76**) and have been regularly examined for biofouling, coral settlement and growth throughout 2020 – 2021 and again in 2023 both far via vessel and close-by via shore (**Figure 77** and **Figure 78**). In the earlier observations since the deployment of the frames, a primary level of growth has been observed on the trial substrates and the supporting steel frames. No major differences in the level of growth were noted between the concrete mat treatment and the natural terrigenous rock. The organisms present on the test substrates included algal turf, barnacles, tunicates, tube worms and gastropods. Monitoring is to continue annually.

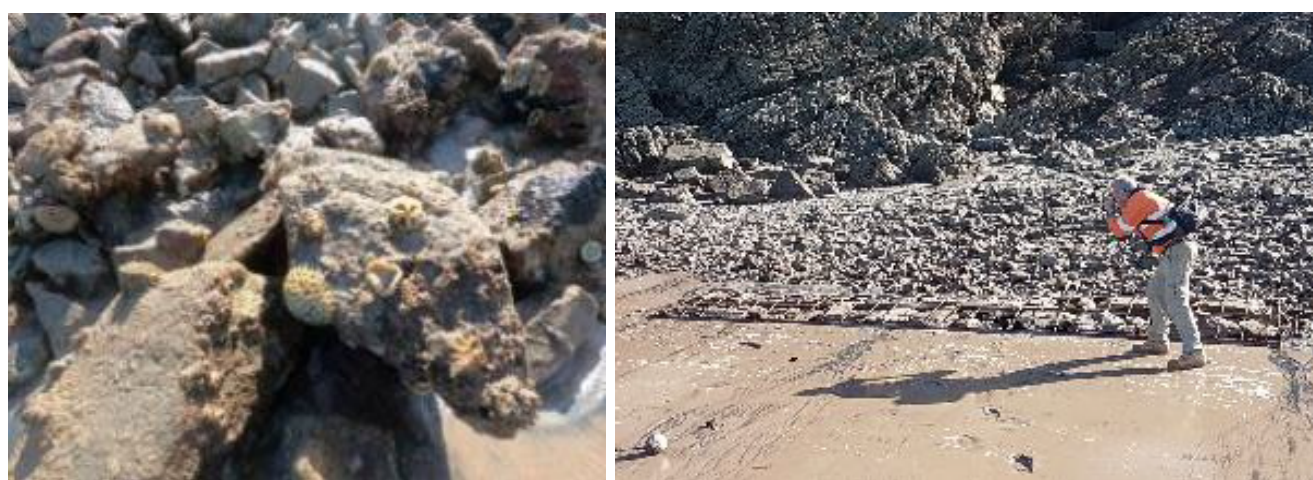
**Figure 78 Examples of long term coral growth on quartzite rock in Jap Bay (left) disembarcating vessel for closer on-shore checks or natural substrate and coral substrate frames (right)**

Quartzite rock in Jap Bay appears to support small sporadic coral colonies when further examinations were made alongshore of surrounding natural substrate but the lack of larger more widespread colonies indicates that, while abundant, the quartzite is not suitable as a short term substrate for colonization (as predicted by Jacobs 2019).

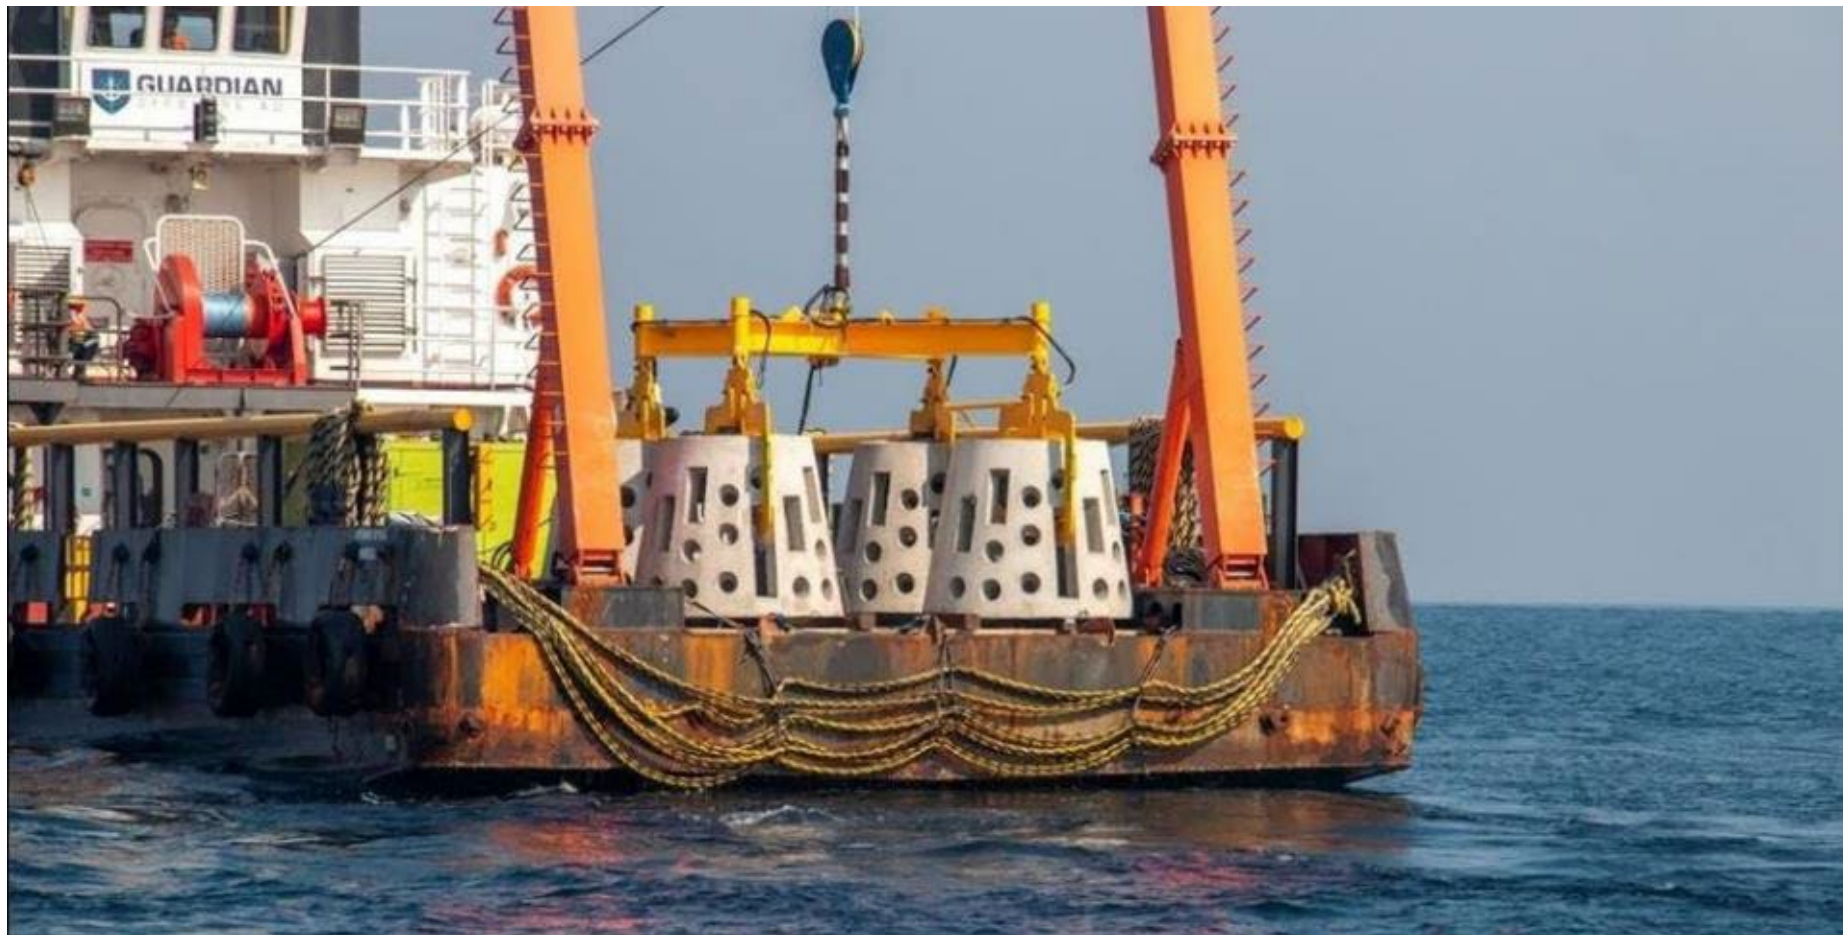
**Figure 81 Example of Bombora habitat enhancement structures being installed at Ocean Reef, Perth (photo credit RecFishWest).**

The modules will be deployed from the deck of one of the Koolan Island supply barges and lowered to the seabed and released mechanically, similar to that seen in **Figure 81**.
