# Koolan Iron Ore Mine and Port Facility Mine Closure Plan

Revision 7 Version 0

31 January 2025

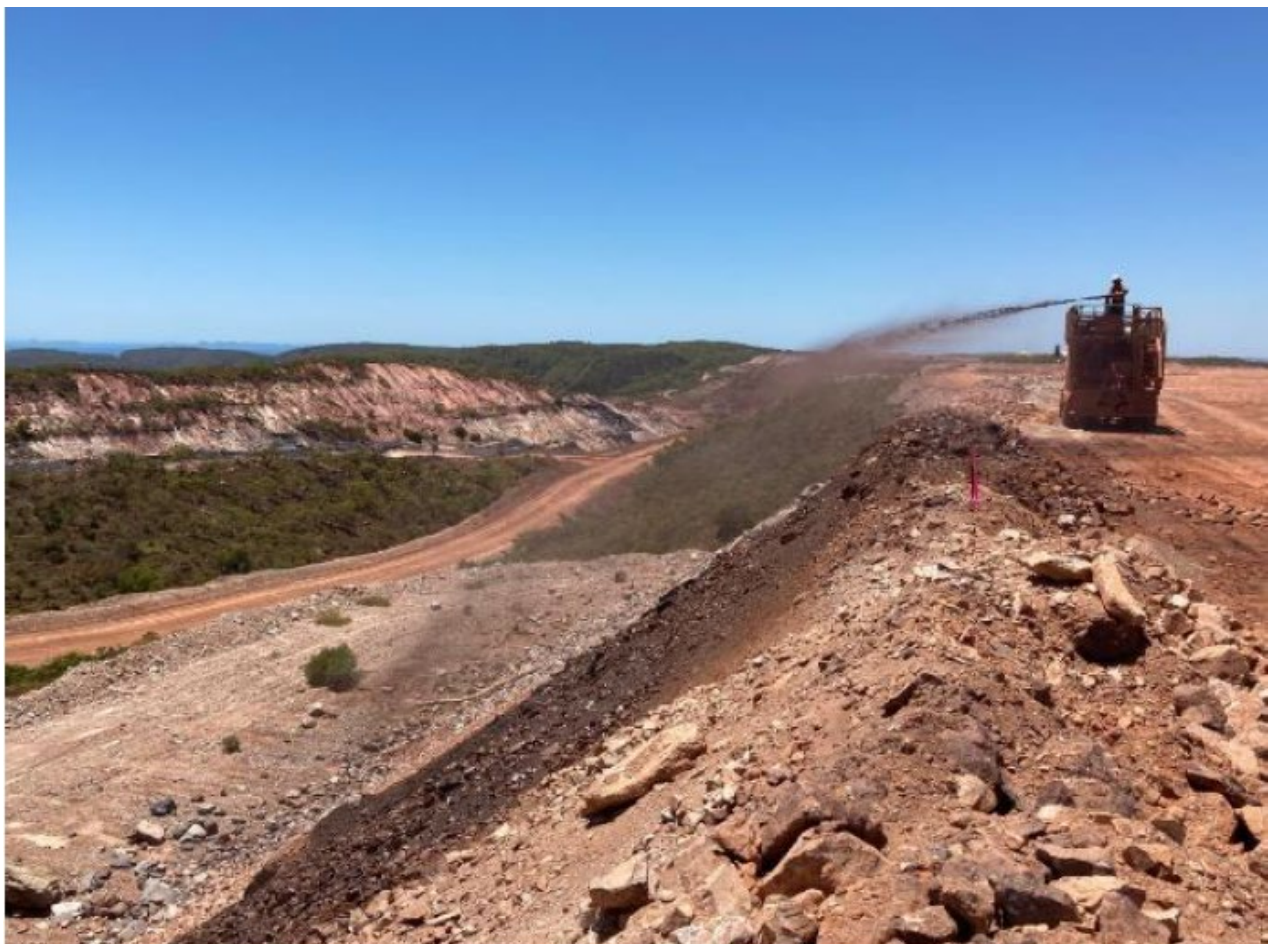
**Figure 82 Hydromulch emulsion of seed in organic growth medium direct sprayed on to an angle of repose.**

In October 2020, a trial was undertaken to test the efficacy and suitability of spray on hydromulch impregnated with seed as an option for revegetating waste rock dumps at steep angles. Hydromulch was applied over of 100m of waste dump slope at a linear length of 25m (0.25Ha). *Acacia*, *Eucalyptus* and *Triodia* species was used in the seed mix applied through the hydromulch (**Figure 82**). two months the hydromulch had washed off the trial slope with the onset of seasonal heavy rains.

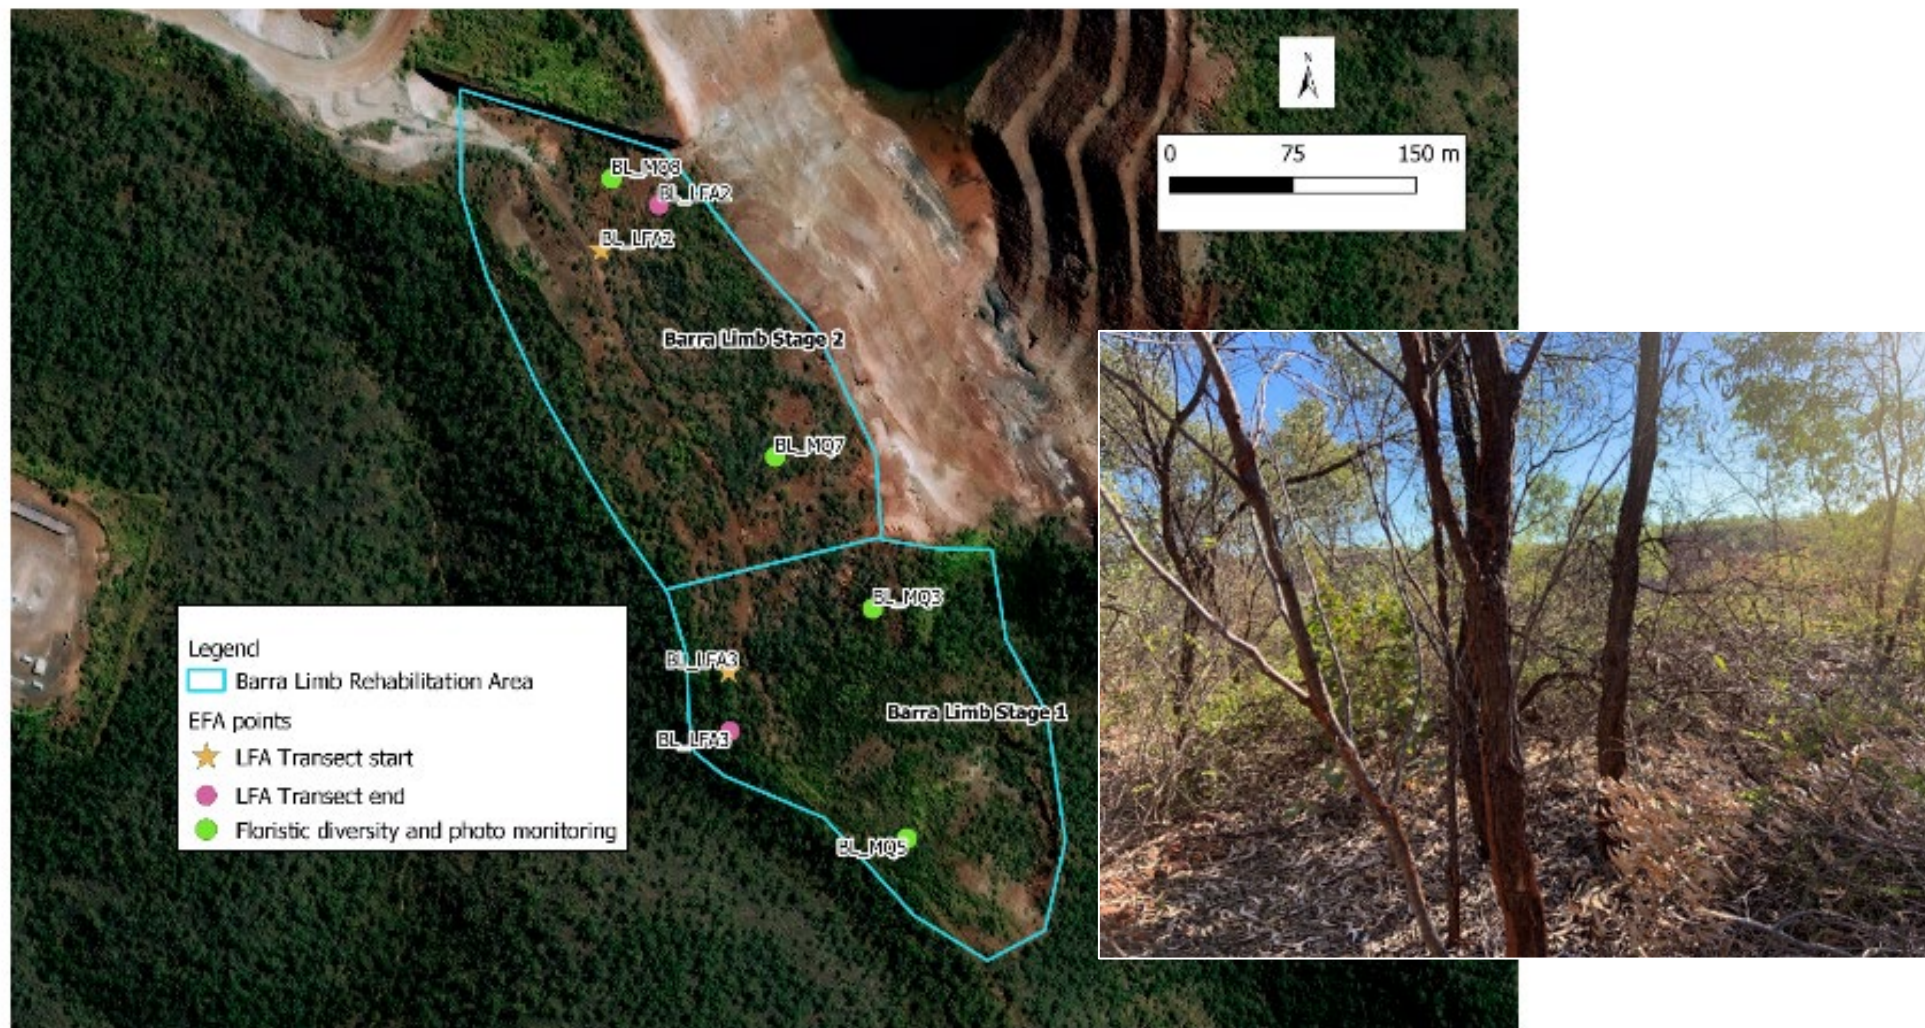
**Figure 87 Barra Limb Rehabilitation monitoring layout. Inset photo taken from BLMQ7 facing east**

Barra Limb Waste Dump was rehabilitated in two stages (**Figure 87**). Barra Limb Stage 1 earthworks were completed in 2009 with slopes battered down to  $<20^\circ$ , covered with approximately 100 – 400 Mm of topsoil and ripped on the contour. Stage 1 rehabilitation was not direct seeded. Plants growing on Stage 1 likely originate from the stored seedbank in topsoil that was respread or have diffused across the boundary with undisturbed areas. Barra Limb Stage 2 rehabilitation earthworks were completed in 2011. Slopes were battered down to  $<20^\circ$ , covered with approximately 100 – 400 mm of topsoil and ripped on the contour. On the steeper southern slope light moonscaping was applied to reduce the risk of erosion. Barra Limb Stage 2 was direct seeded with  $7.1 \text{ kg ha}^{-1}$  of seed mix contained 105 species developed from 10 analogue quadrats located in undisturbed Open Woodland across the Island. Soil testing by the Soil Water Group (Soilwater Consultants, 2015) indicates that Barra Limb Stage 2 surface is siltstone. The area has been monitored 10 occasions between 2012 and 2023.

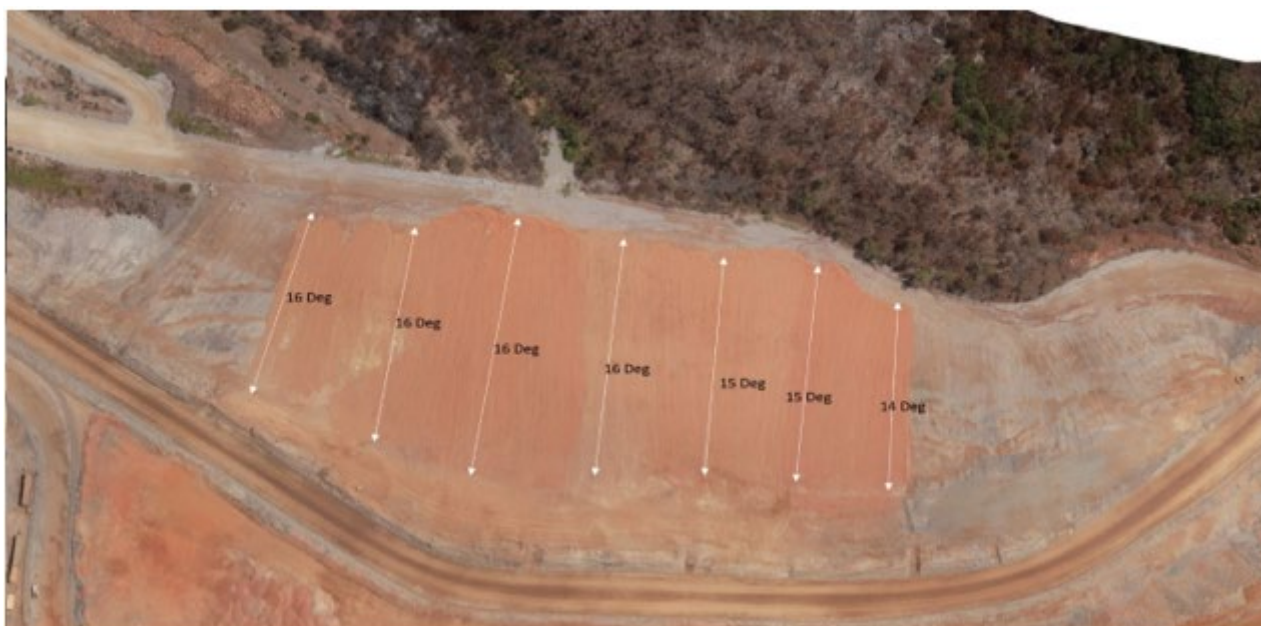
**Figure 95: Capture of WRD5 showing angle of slope is <20° across the face.**

In 2023, a single large outer slope on WD5 was identified as available for rehabilitation. Given the size and angle of the slope (**Figure 95**), a covering media trial tested the suitability of siltstone as an alternative growth medium at a large scale and identify optimum cover thickness. The slope was divided into eight different cells (two replicates of each of four treatments), represented in **Figure**

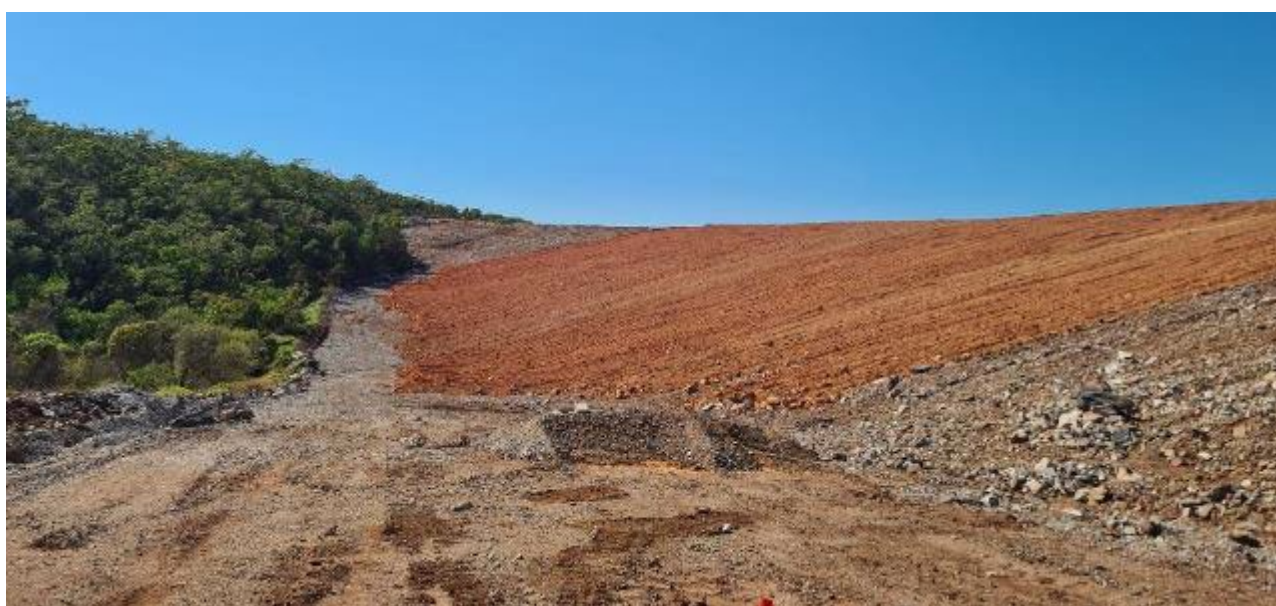
**Figure 97: Final Slope Cover prior to on-contour ripping; August 2023.**

Within the eight cells, four different depths of siltstone were applied with each depth occurring twice to ensure results are replicable. The four cover depths trialed were 100mm, 250mm and 500mm and two cells that do not have siltstone applied (0mm) for control purposes: the depth of the siltstone treatment of each cell is represented in **Table 31**. The final trial surface was treated by top dumping siltstone and working the siltstone down using in machine informed by GPS to create the thickness required in each cell; a final cover and aspect is shown in **Figure 97**.

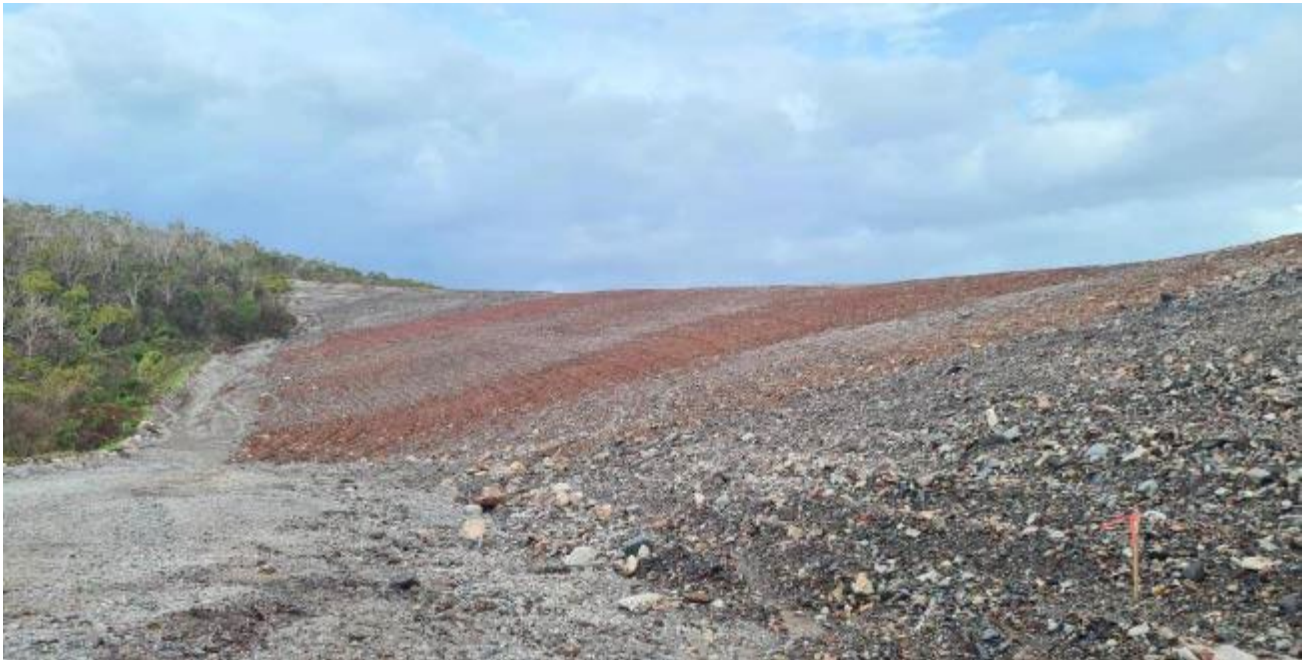
Following several rain events greater than 20mm a visual inspection was made in late February. No signs of vegetation growth were observed during the inspection. Soil was moist and fine siltstone had settled within windrows. No major erosion is occurring across the rehab area including no run off of siltstone to the base of the slope. Each cell is now clearly visible by the different depths of the ocre coloured siltstone.

**Figure 99: Slope post rainfall, Late February 2024.**

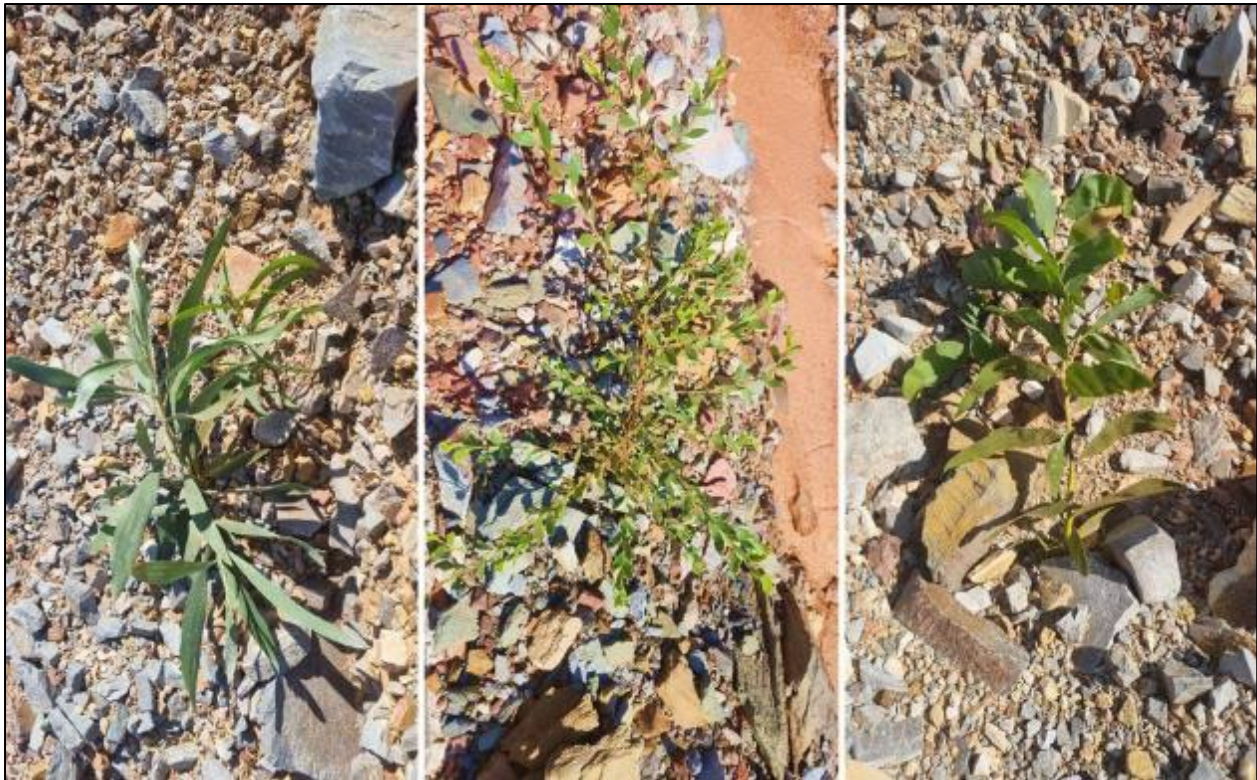
Early indicative monitoring presents promising results, there was one erosion feature that occurred due to water pooling at the top surface of the slope. The erosion was between two cells, which allowed vertical water migration. The upper face of the slope has been reformed to hopefully prevent further erosion. Approximately six months post seeding saw the emergence of the first germinates. There is no specific correlation between growth media depth and germination present at this stage.

**Figure 100 Initial seed germination occurred approximately six to eight months post seeding.**

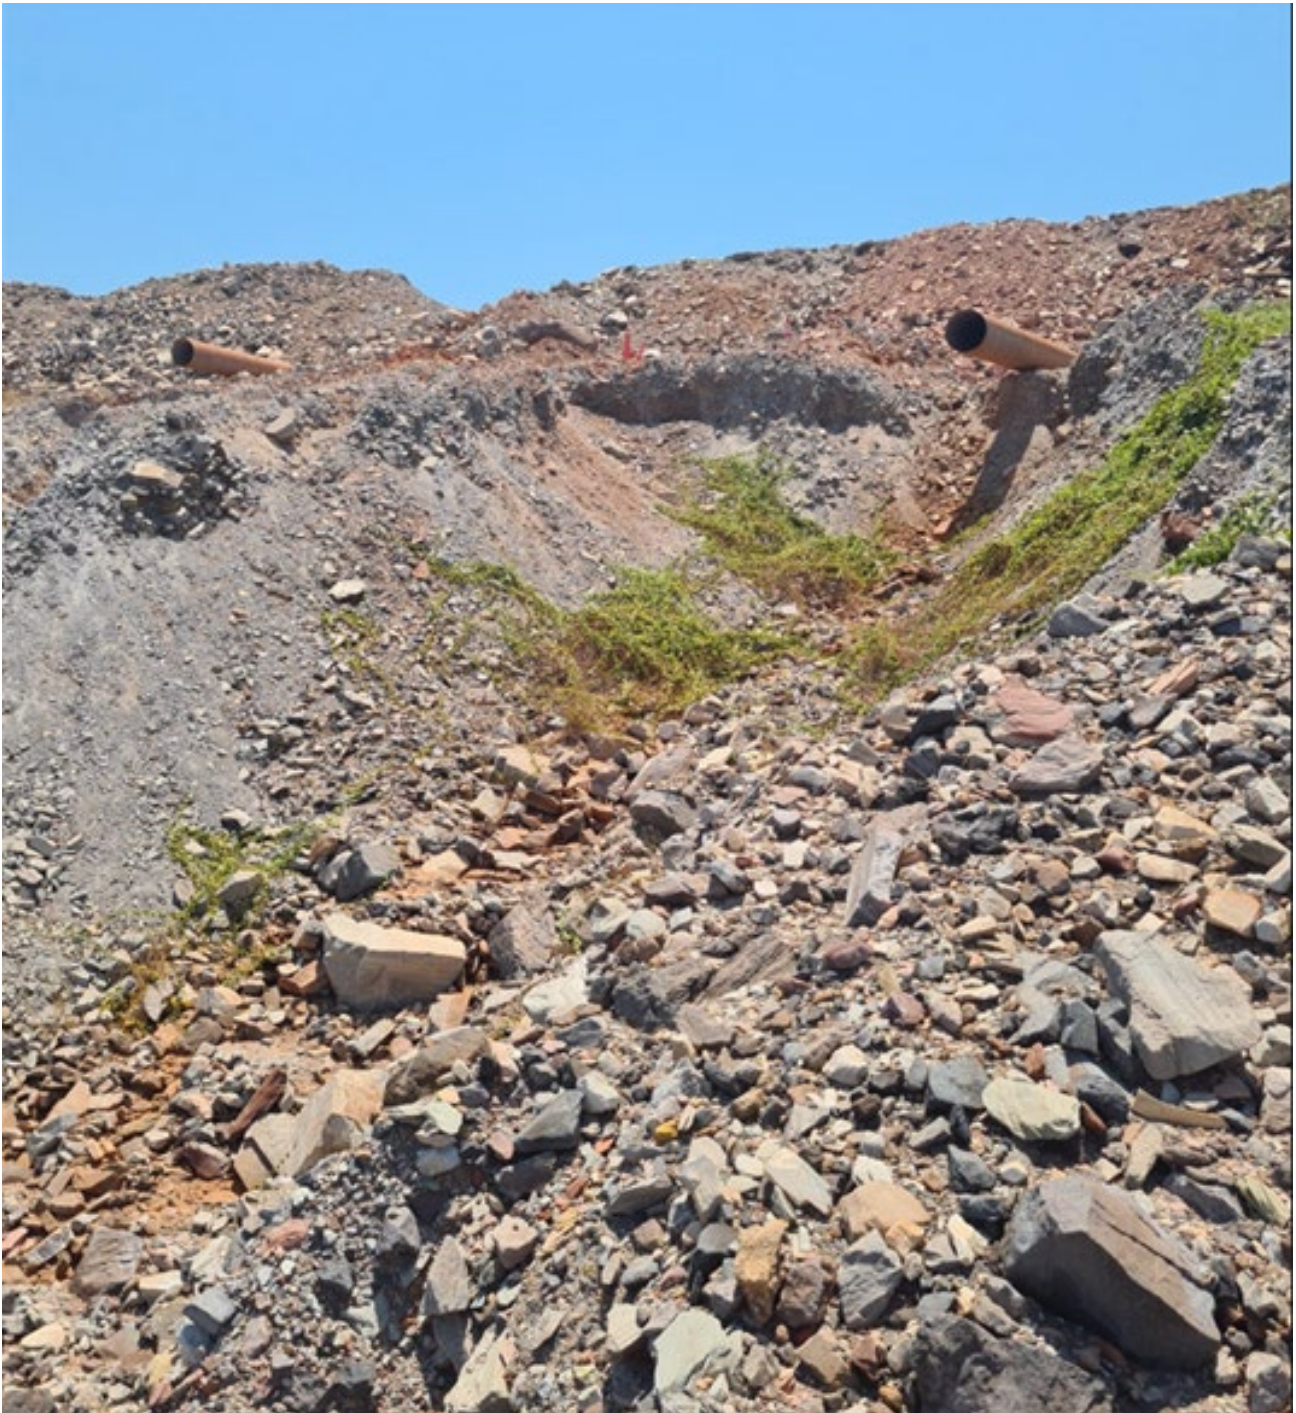
**Figure 101 Erosion Feature on WD2 prior to remediation.**

During an Environmental inspection by DEMIRS in June 2023 it was identified that there was erosion occurring due to surface water management on WD2. The erosion channel initiated from two water management drains to prevent flooding on the adjacent haul road and mining operations centre (**Figure 101**).

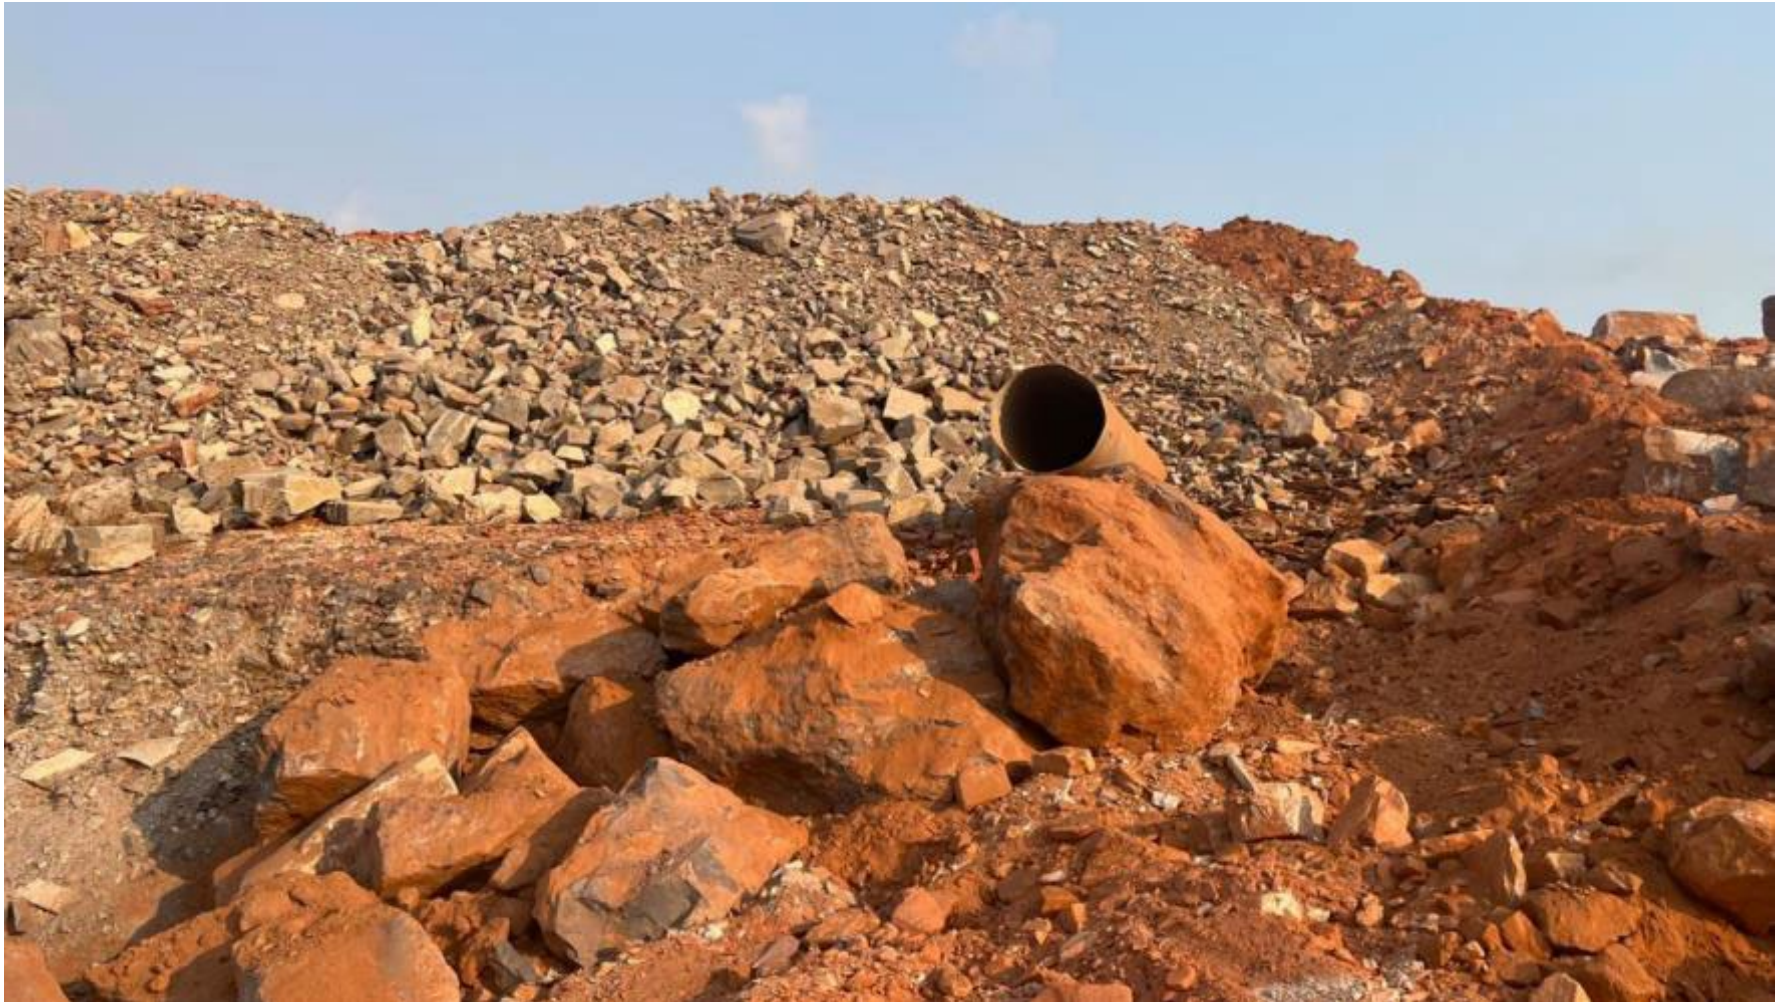
**Figure 102: surface water drain after remedial works were carried out (October 2023).**

To prevent further erosion occurring KIO technical services placed approximately 1000 tonnes of oversized quartzite pieces under the discharge outlets. This was considered the best available option due to the location of the outlets. The additional quartzite was intended to reduce the overall drop from the outlet to the underlying waste rock dump and improve erosion resistivity. The remedial works were undertaken in October 2023. **Figure 102** shows the remedial works undertaken to backfill the erosion channels and significantly reduce the vertical drop from the outlet to the underlying media.

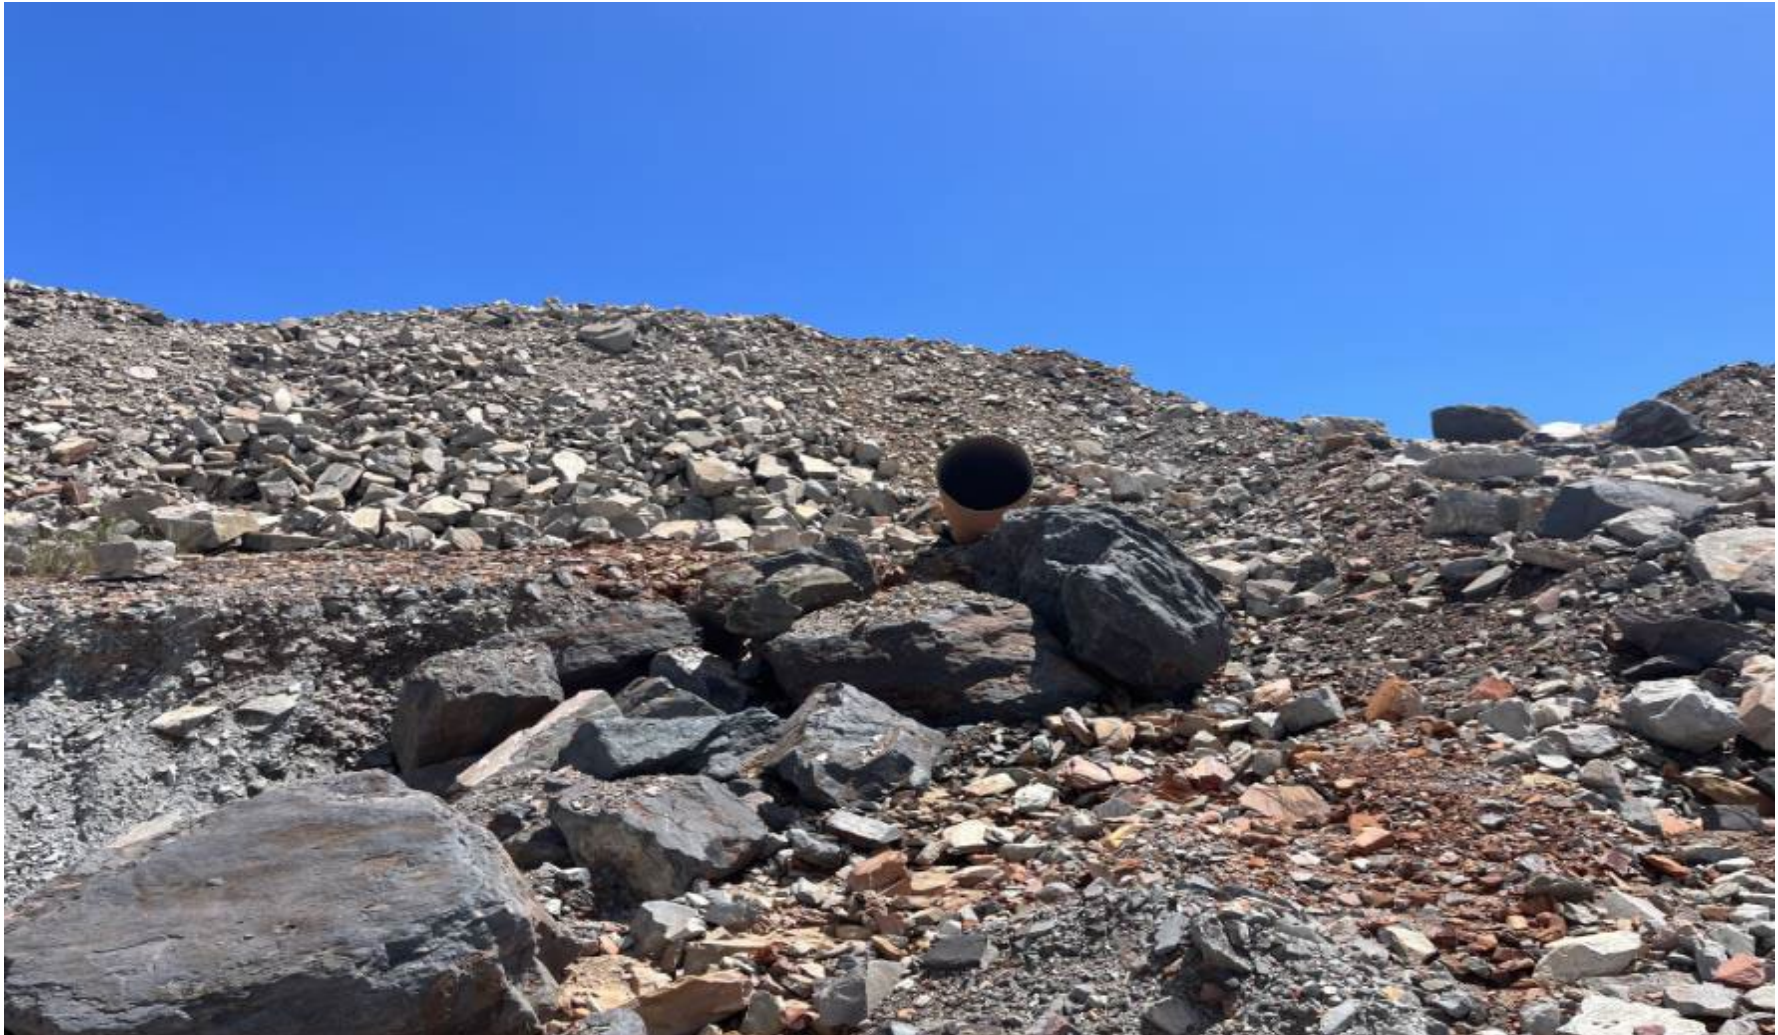
**Figure 103: surface water drain after wet season (March 2024).**

The earthworks were monitored in late March 2024, after the majority of expected rains, to understand if the solution withstood extreme rainfalls events that occurred during February 2024. After the 2024 wet season there are no signs of additional erosion, and therefore fix is considered successful (**Figure 103**).

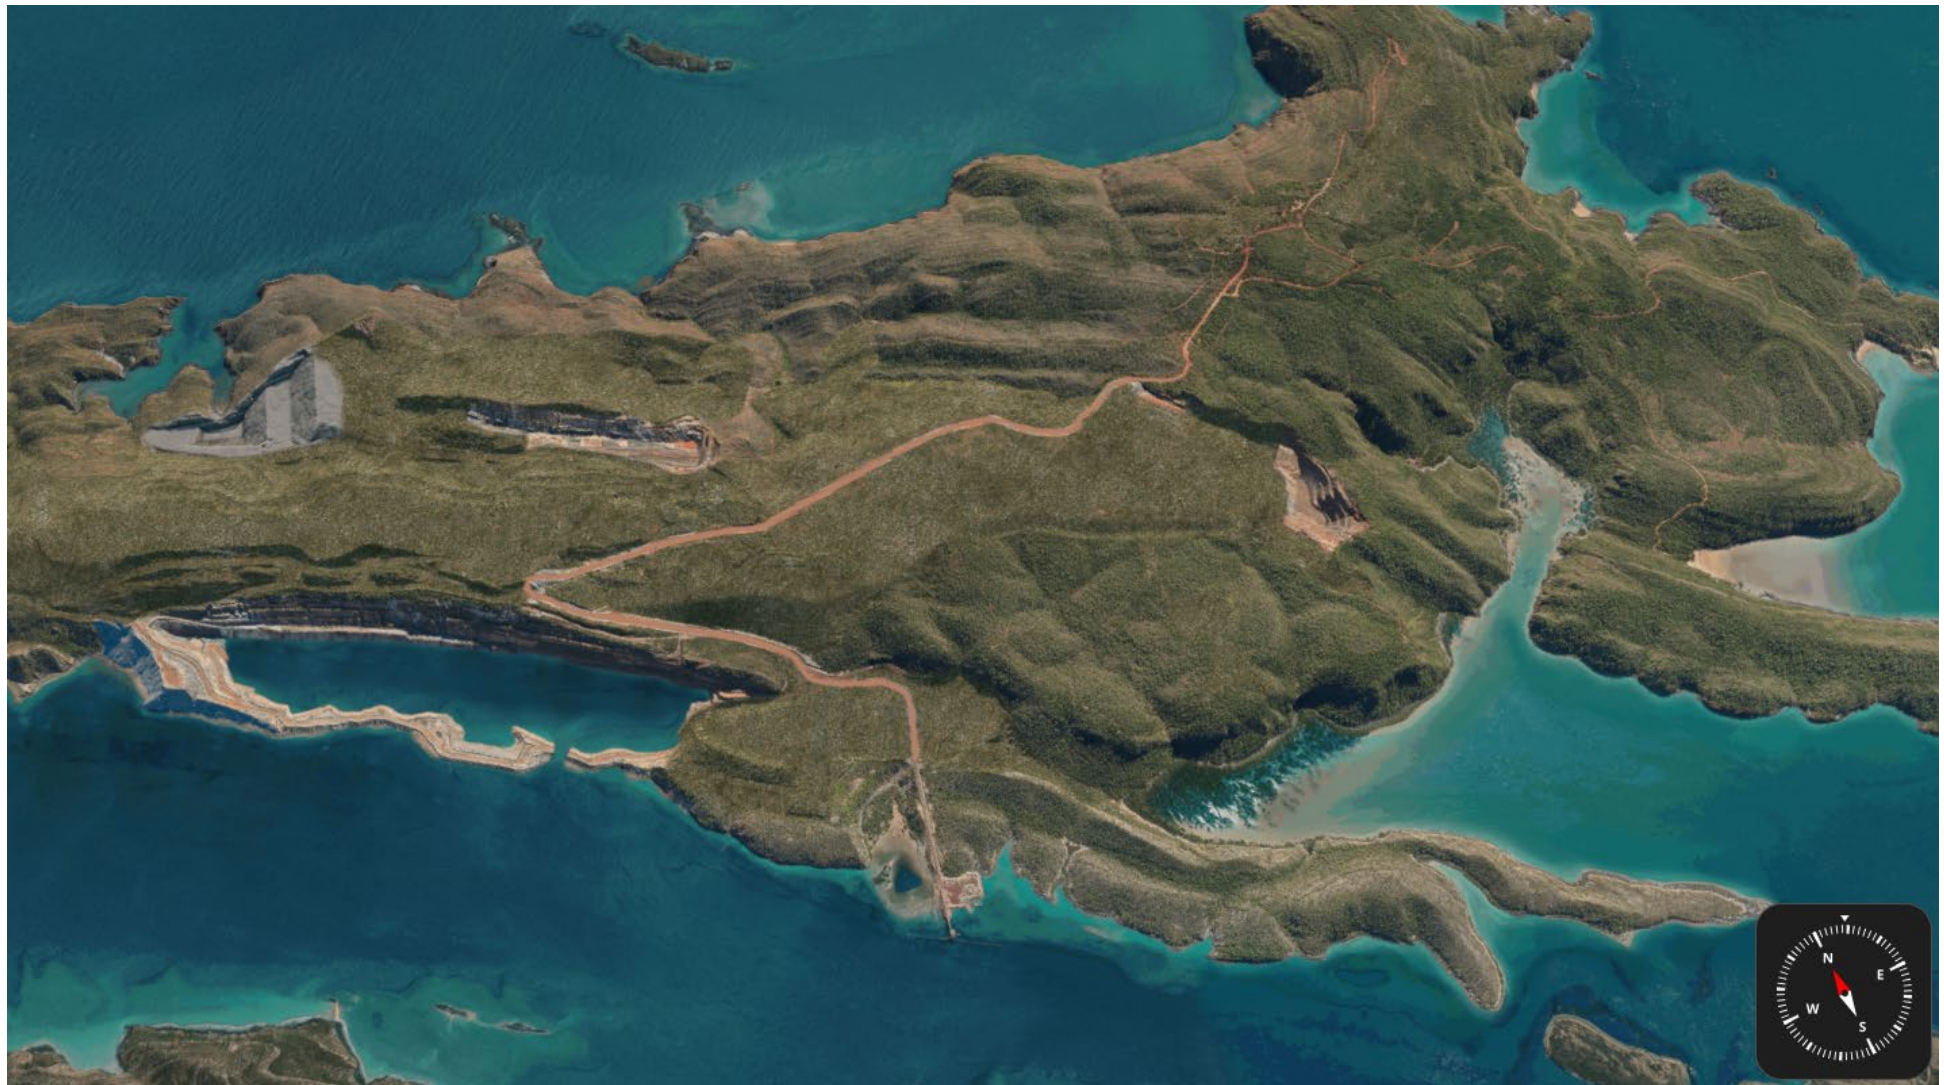
**Figure 104: Closure Option 1**

KIO engaged Truescape to develop a 3D interactive tool to visually represent closure options 1 and 2. This tool allows navigation around Koolan Island to see what the post-mining land could look like. A snapshot of each option is presented as **Figure 104** and **Figure 105** respectively.

- Open pits,
- WRDs,
- Seawall
- Saline water dams,
- Plant sites,
- Run-of Mine Pad, and
- Miscellaneous Mining Activities.
- Final closure options are shown in **Figure 104** and **Figure 105** and closure Domains are shown in **Figure 106** through **Figure 134**.

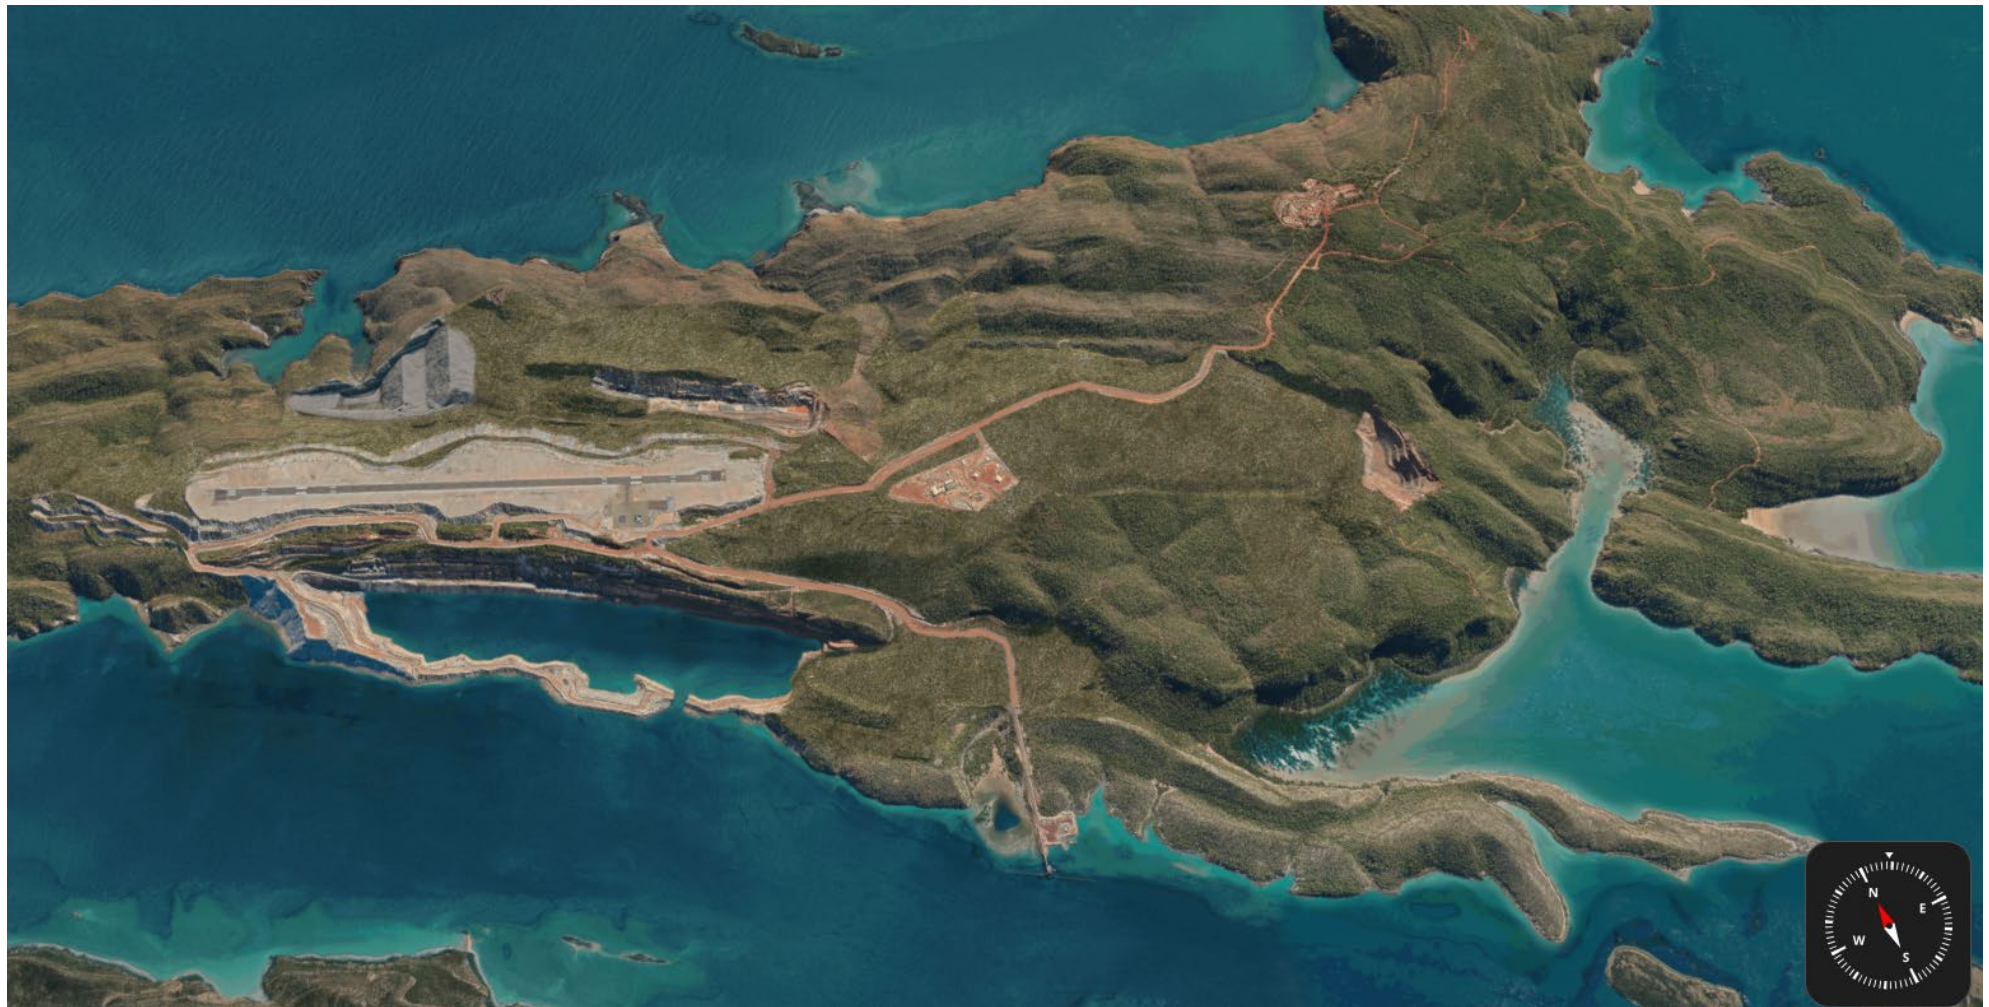
**Figure 105: Closure Option 2**

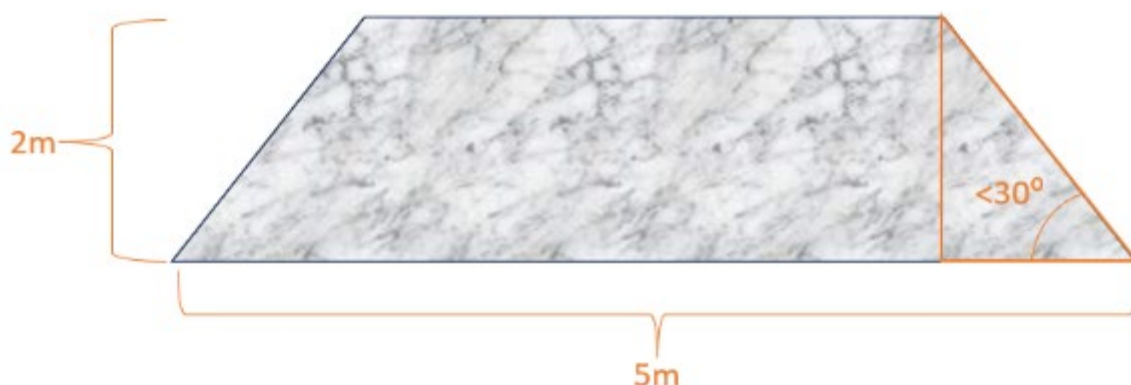
**Figure 107: Minimum Specification of an abandonment bund**

To meet the criteria above abandonment bunds will be built using the minimum specifications presented in **Figure 107**.

Based on the understanding of the available materials on site the abandonment bunds will be constructed of quartzite. This material is erosion resistant and blocky creating a free draining structurally stable abandonment bund.

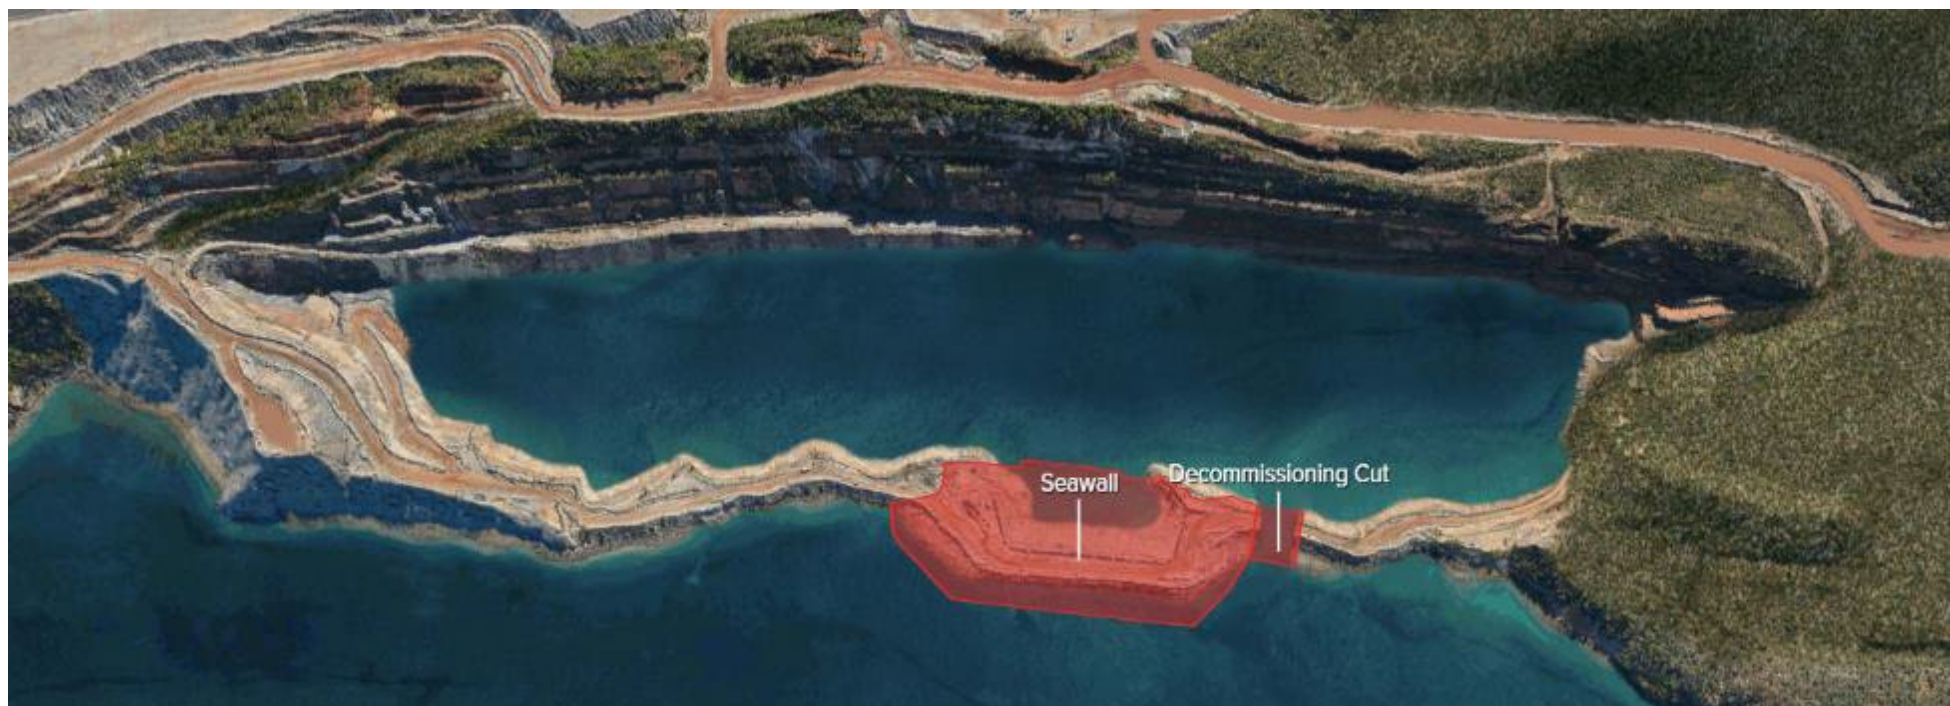
**Figure 108 Conceptual tidal trench location through the coastline natural modified abutment**

Main Pit will be largely flooded/inundated with seawater which is expected and allowed to be tidally influenced via a decommissioning cut trenched to the east of the seawall (**Figure 108**). The seawall and decommissioning cut closure implementation is discussed in Sections 21.3.

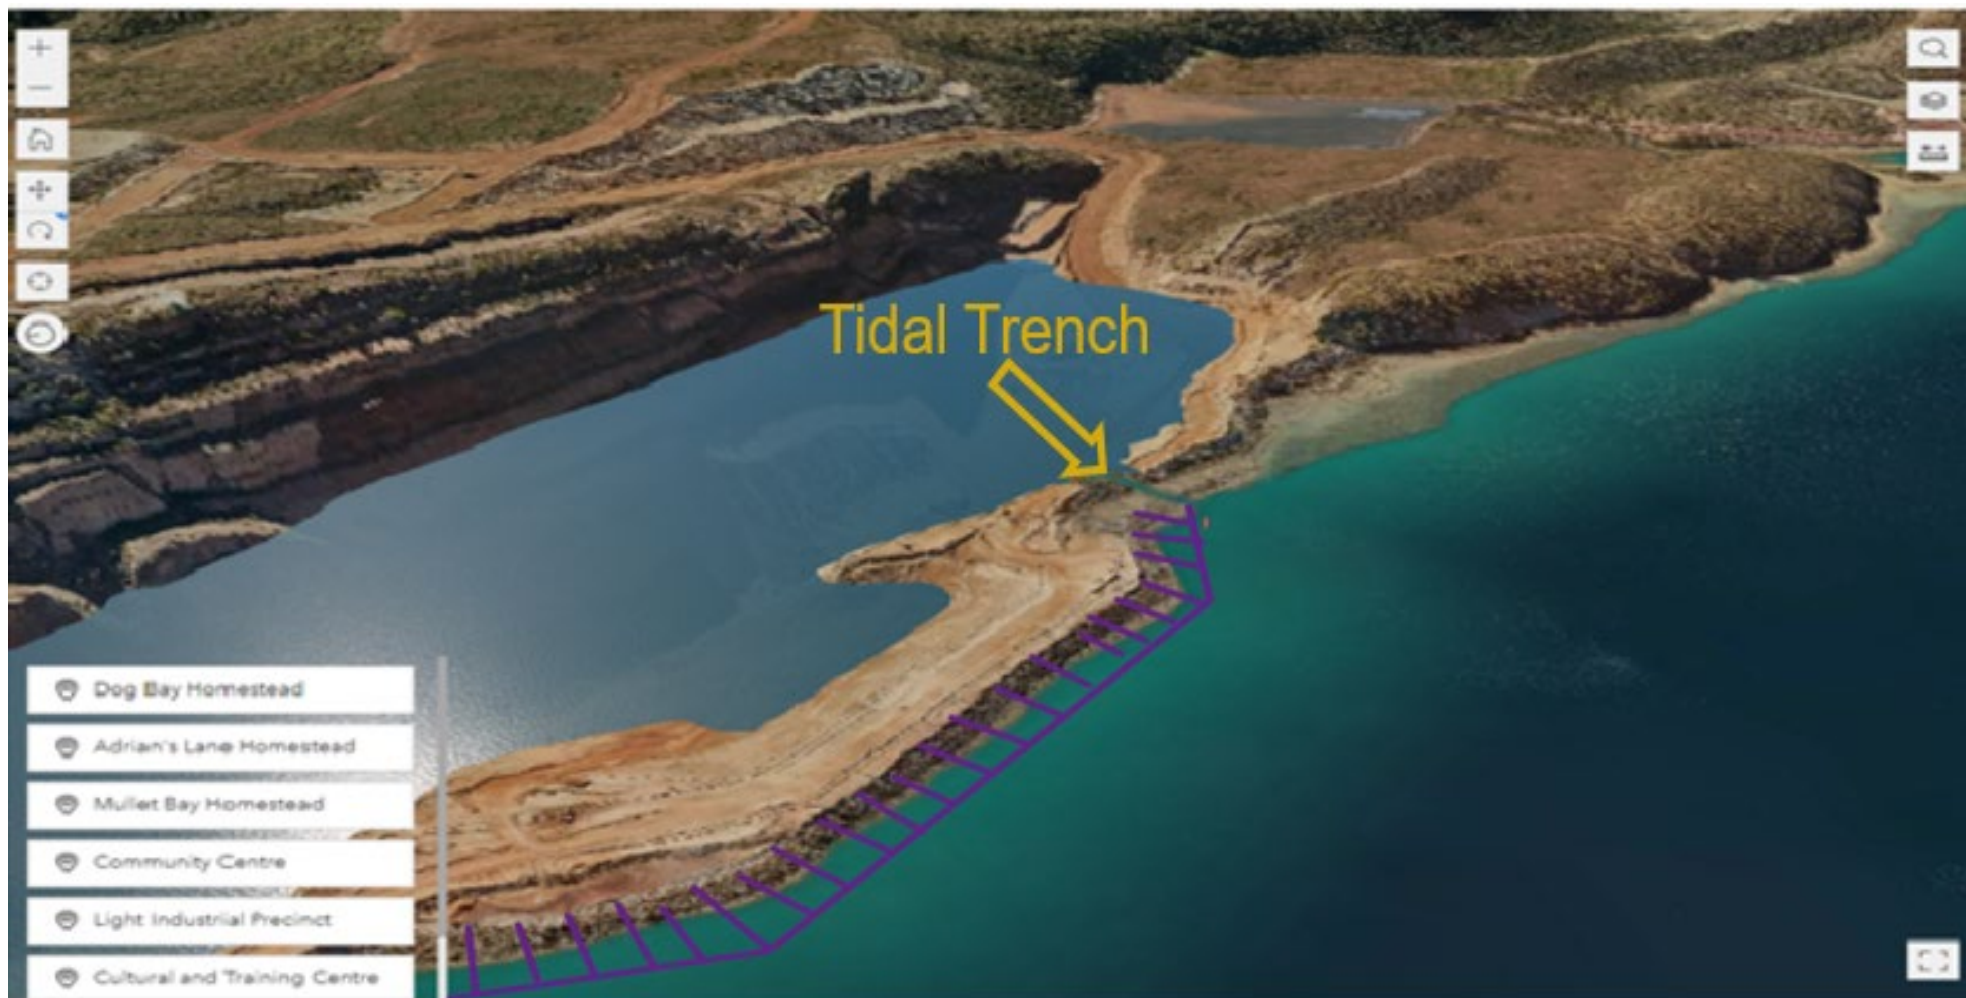
**Figure 109 Conceptual closure design of the seawall and decommissioning trench. Purple shows outer armour rock re-processing zone**

The final pit shell is shown in **Figure 109**, as the pit will be inundated, and the water quality is suitable for benthos, the zone that has the potential to host corals and other marine biota has been identified and artificial reef may also be installed to promote hard coral growth in these areas. The coral inhabitable zone has been highlighted green on **Figure 110**.
