# Koolan Iron Ore Mine and Port Facility Mine Closure Plan

Revision 7 Version 0

31 January 2025

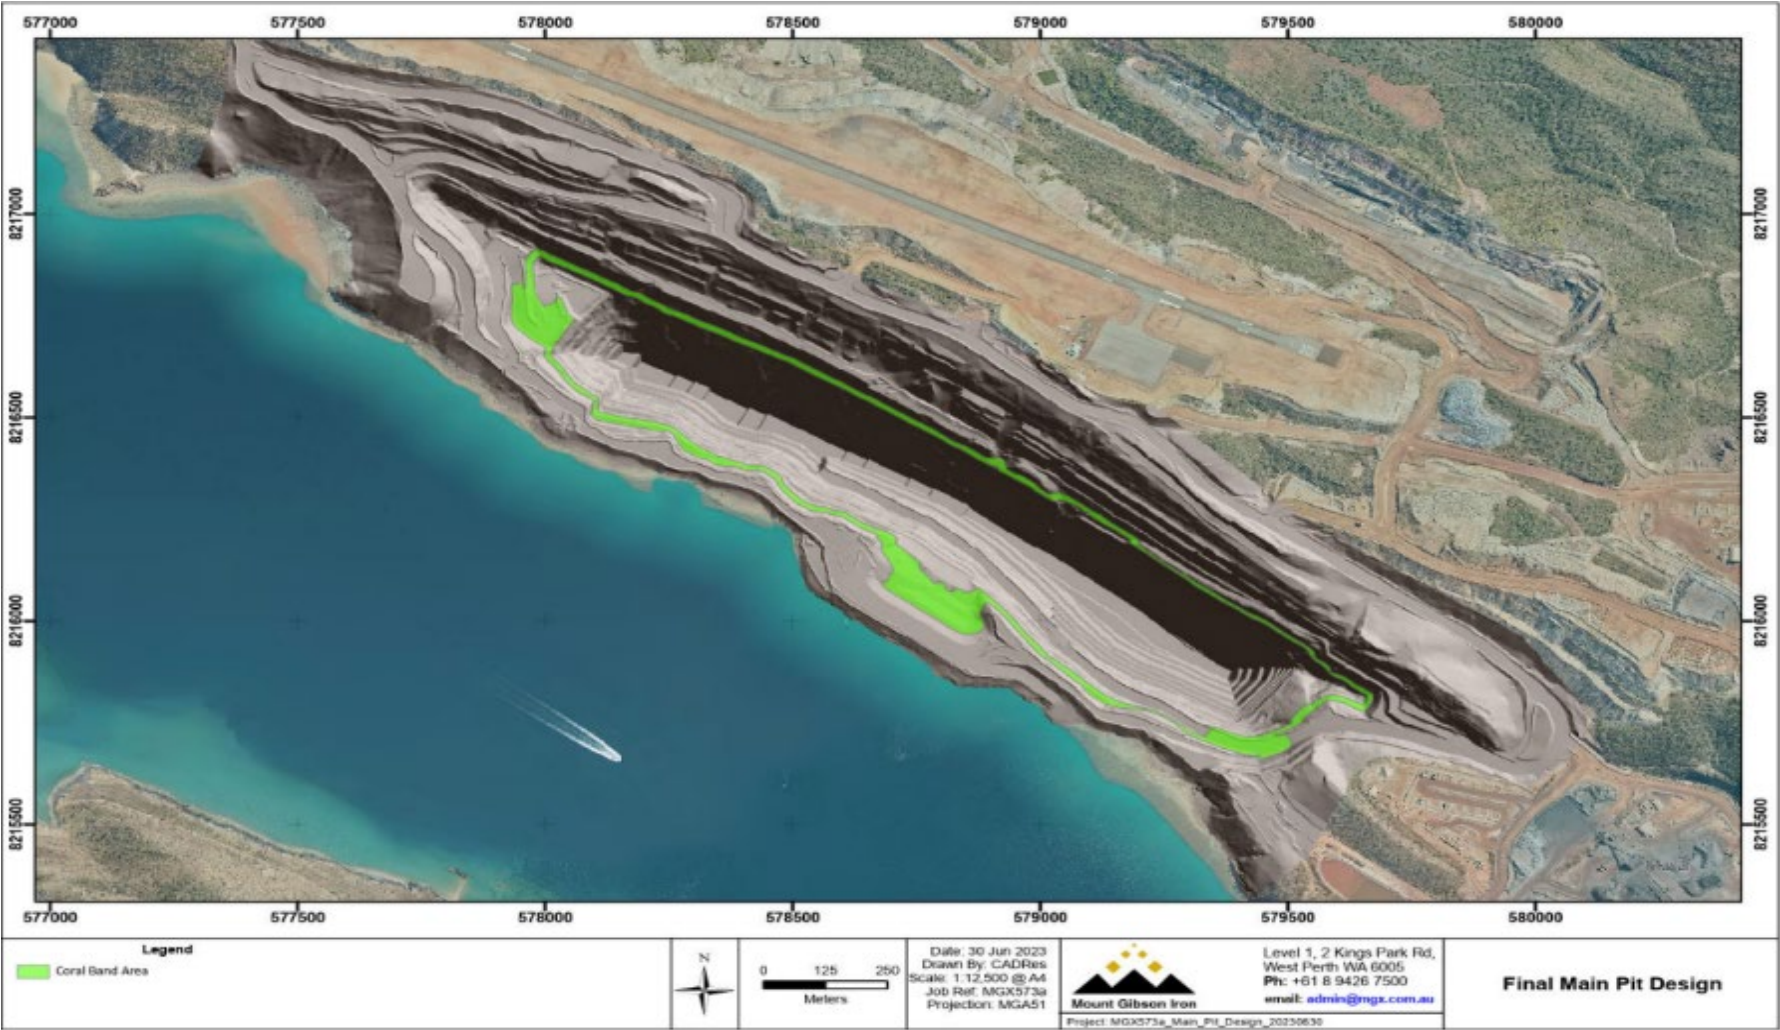
**Figure 110 Conceptual closure over Main Pit. The green band represents benches potentially available for coral habitat as they occur in the forecast photic zone.**

The final pit shell is shown in **Figure 109**, as the pit will be inundated, and the water quality is suitable for benthos, the zone that has the potential to host corals and other marine biota has been identified and artificial reef may also be installed to promote hard coral growth in these areas. The coral inhabitable zone has been highlighted green on **Figure 110**.

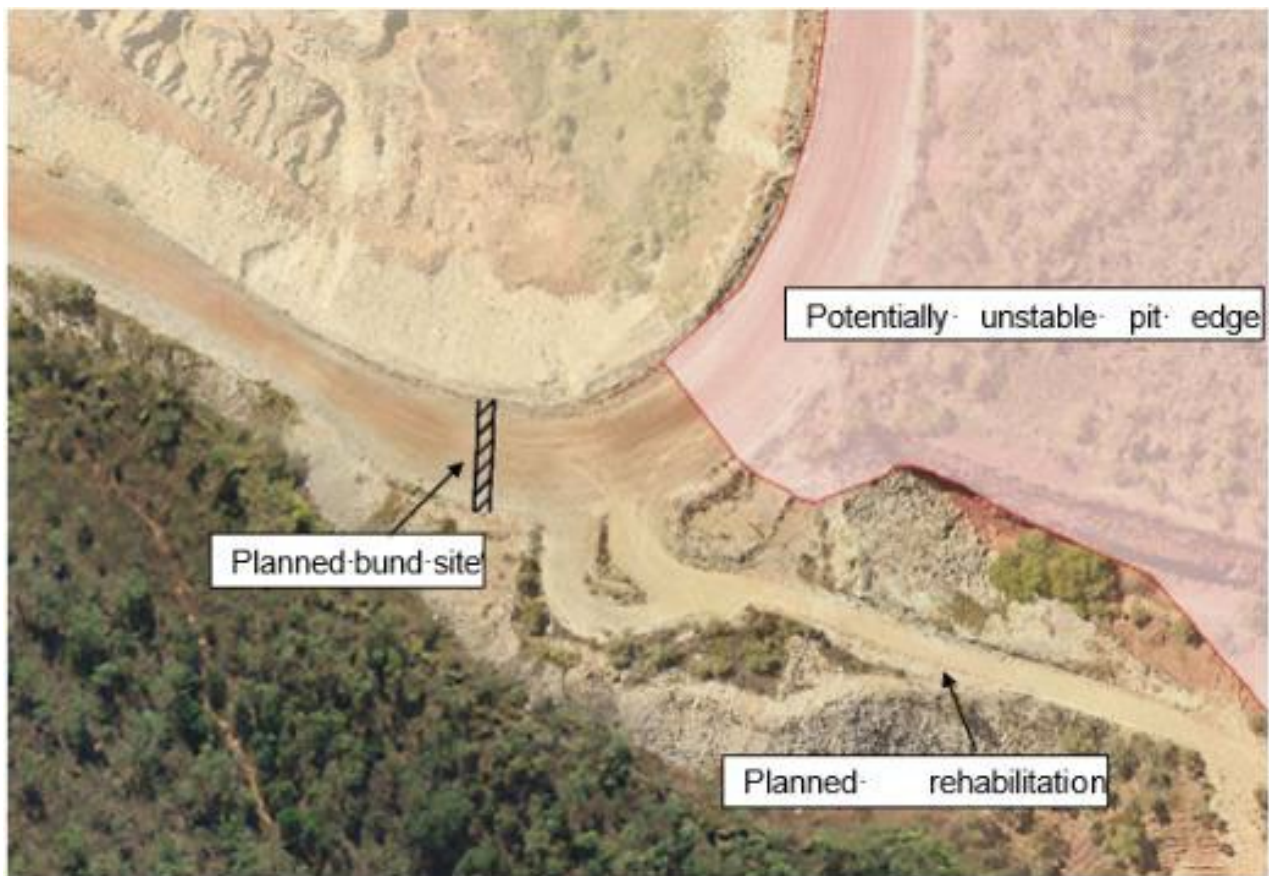
**Figure 115: East Pit Abandonment Bund Location**

In lieu of abandonment bunds to the south the rugged terrain will prevent inadvertent access. To the North strategic development of WD5 and closure of the main haul road will serve as an abandonment bund. The small section of abandonment bunding required across the eastern access road on the southern border of WD5, this is illustrated in **Figure 115**.

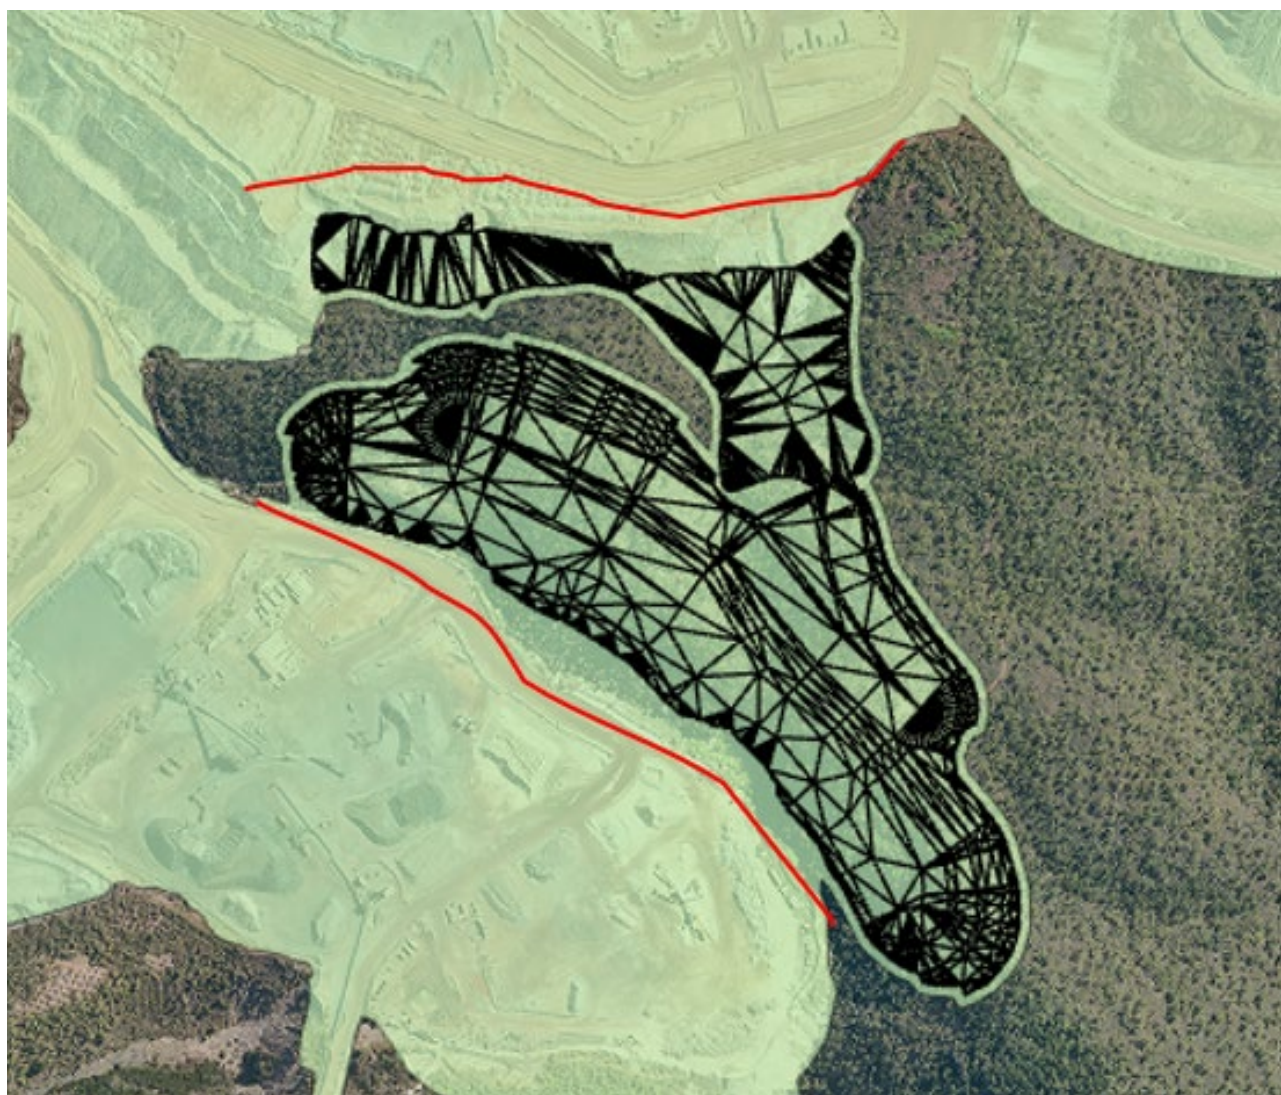
**Figure 116: Conceptual location of the Mangrove deposit planned pit abandonment bund.**

Mangrove pit is a resource that is yet to be mined. The pit will have been planned, however, geometry may change to facilitate optimisation. Based on the current pit design the floor of the pit will cease at approximately 15m below the ROM/Stockpile area. This will result in a remnant void at closure. Until a final pit design has been executed and the zone of pit instability has been defined by geotechnical engineers a conceptual abandonment bund location is provided on **Figure 116**.

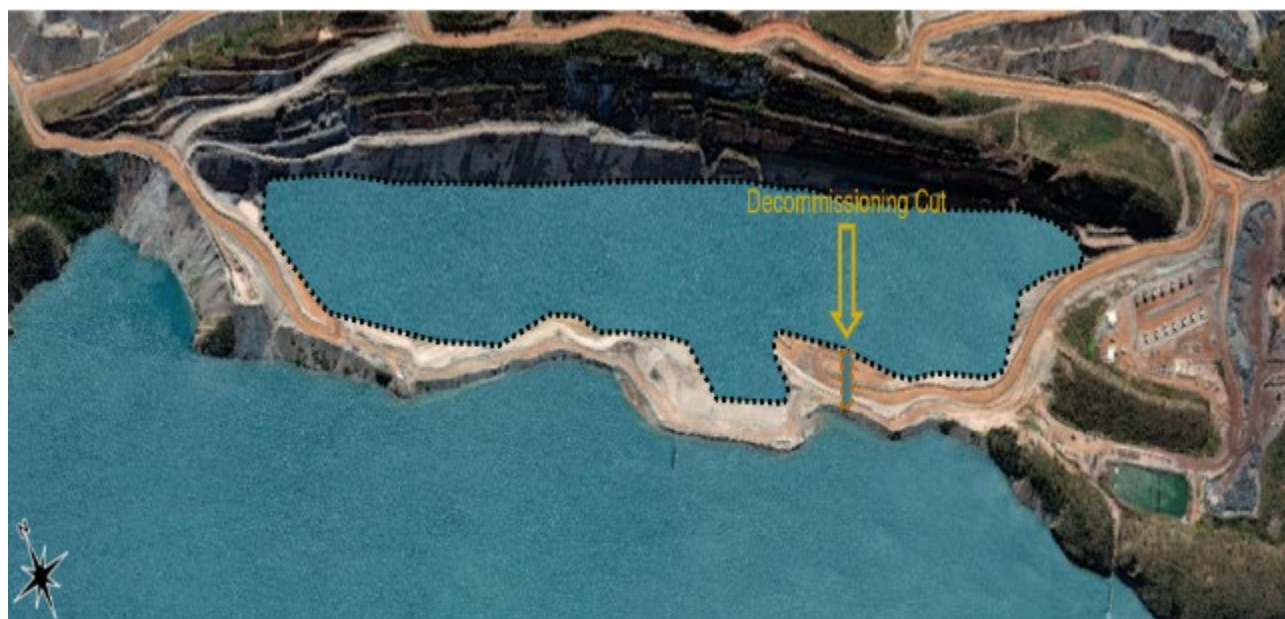
**Figure 117: Conceptual location of the Decommissioning Cut (location, size and water levels are all approximated).**

There will be a single trench build to the east of the seawall, conceptually presented in **Figure 117**.

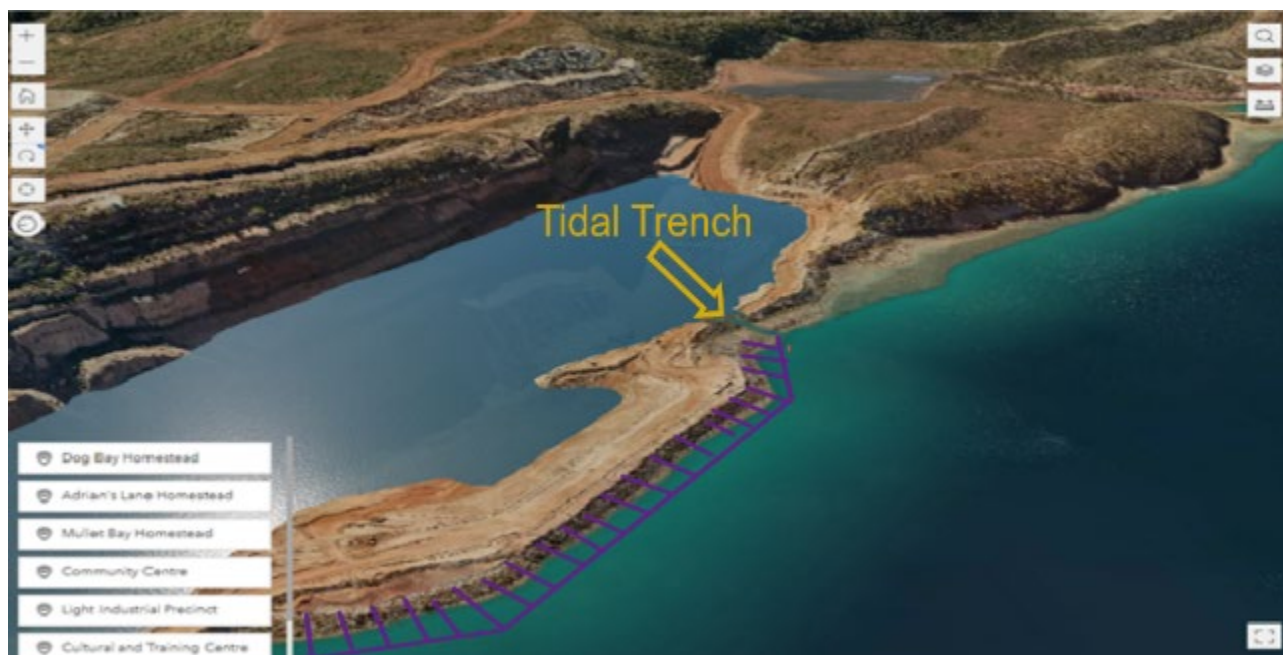
**Figure 118 Conceptual closure integration of the seawall and decommissioning cut.**

The Decommissioning Cut will be built into the natural fill and sufficiently armoured to mitigate erosion forced of the tidal movements. The design of the decommissioning cut will need to take into account the additional closure armouring and re-sloping of the seawall proper. Conceptually the integration of the seawall and the decommissioning cut is shown in **Figure 118**.
